Otter Lake Shoreline Assessment Summary Report

July 2016

Submitted to the Otter Lake Land Owners' Association Inc. by Watersheds Canada and the Canadian Wildlife Federation.

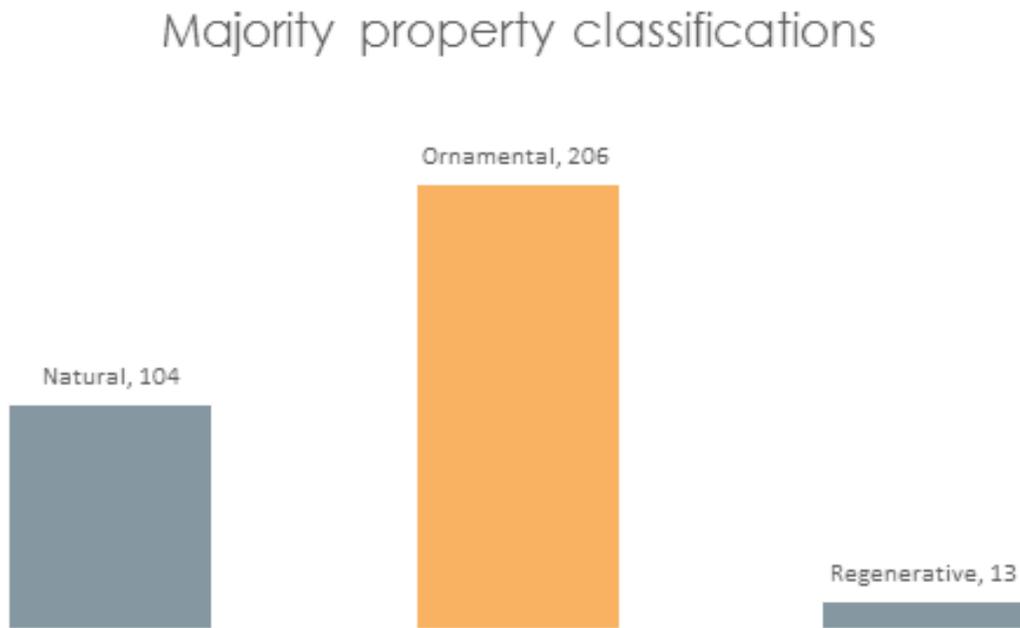
Figure 1 Property Classifications

Figure 1 shows the counts of property classifications on the lake. Properties were assigned an overall category corresponding to the classification that made up the largest portion of the shoreline.

On Otter Lake, 104 of shoreline properties were classified as majority natural, 206 majority ornamental and 13 were considered majority regenerative. It is recommended that shoreline property owners engage in naturalization projects to further decrease the ornamental percentage and increase the regenerative and natural percentages.

This presents an opportunity for residents of Otter Lake to increase the overall quality of the lake by maintaining, protecting and enhancing natural shorelines. To restore shorelines to a more natural state, property owners are encouraged to take action. Regenerative properties should also be encouraged to maintain their properties in a natural state by allowing their vegetation on their property to continue to regenerate and grow naturally.

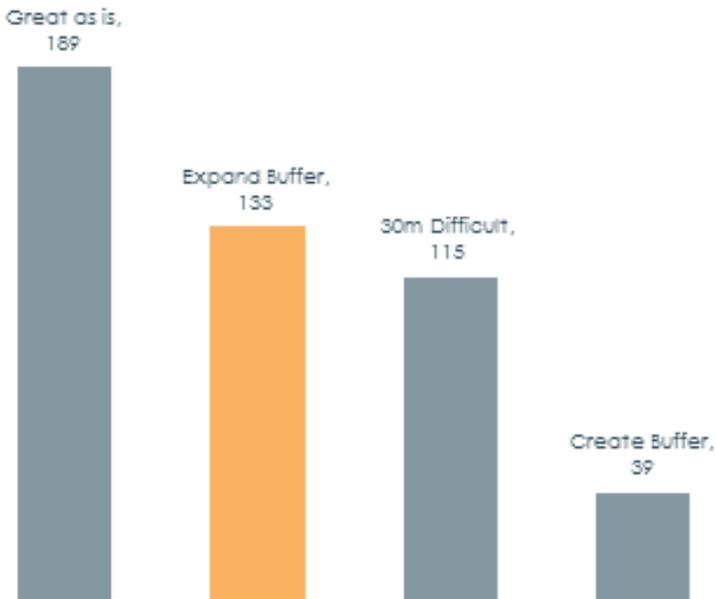
Figure 2 Buffer Recommendations

The survey of Otter Lake characterized the types of restoration opportunities that exist around the lake on individual properties. Figure 2 summarizes the number of properties that were assigned a buffer recommendation during the survey. Each shoreline property can receive more than one recommendation.

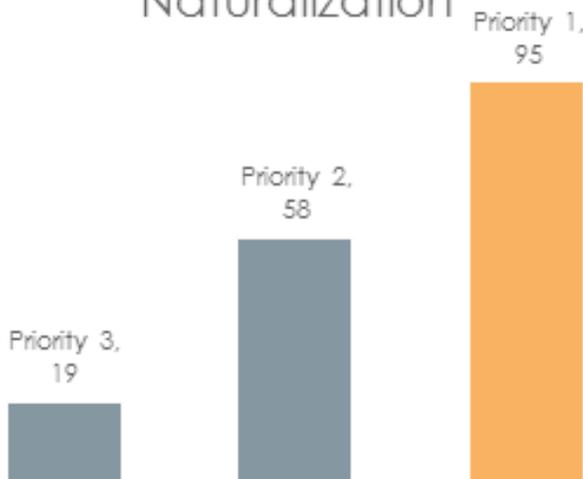
Figure 3 Shoreline Naturalization Property Rankings

Currently 172 properties would benefit from shoreline naturalization. Of these 172 properties, 95 or 55% of properties are a top priority.

In order to determine restoration opportunities on the lake, properties that were assigned a recommendation to expand or create a vegetated buffer were identified and ranked according to their potential for restoration as follows.

Priority 1: Properties that have an ornamental or degraded shoreline proportion of greater than 75%, potentially offering an opportunity for significant areas of naturalization.

Priority 2: Properties that have an ornamental or degraded between 50% and 75%.

Priority 3: Properties where the ornamental or degraded shoreline proportion is between 25% and 50%. These properties still have areas where there is opportunity for restoration; however they are likely already in a fairly natural condition.

It is recommended for the health of a lake that 75% of the shoreline of each property remains natural, leaving 25% for shoreline development opportunity. Working towards keeping 75% of the shoreline of each property in a natural state will greatly benefit the health of the lake.

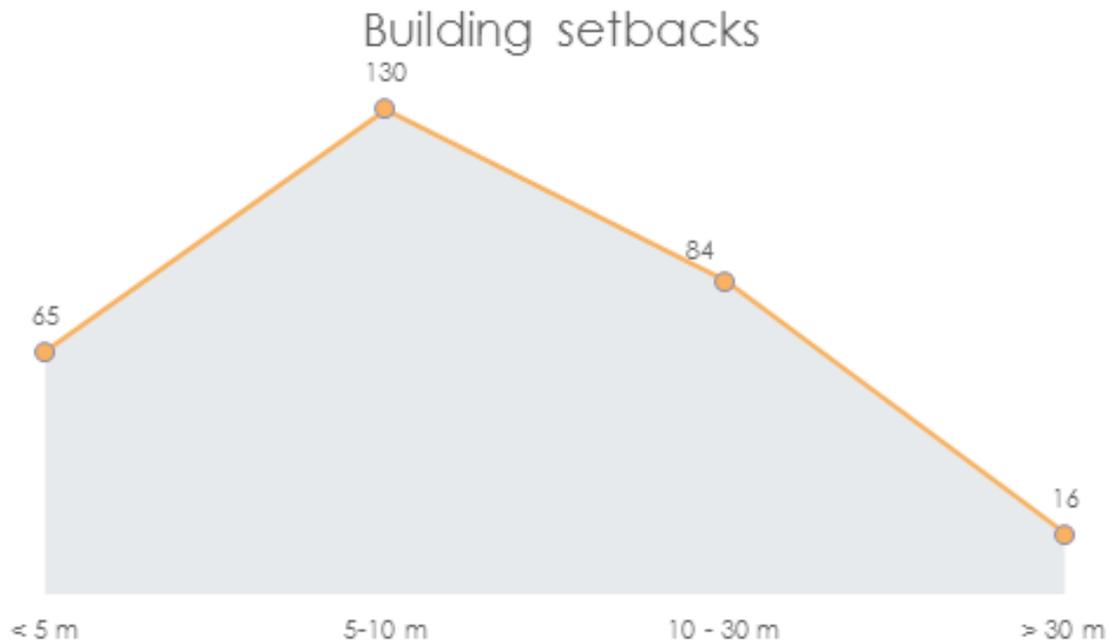
Figure 4 Building Setback Ranges

Shown in figure 4 is the range of building setbacks for properties on the lake, not including vacant properties, buildings under construction and unidentifiable properties. Building setbacks for shoreline developments in Ontario should be at least 30 metres from the high water mark; however, older cottage buildings were permitted closer to the high water mark. On Otter Lake, 85% of the properties surveyed were observed to be closer than 30 metres to the shoreline.

A potential area of concern with building setbacks is having septic systems installed close to shore. Regular inspections and maintenance of septic systems can help prevent excess nutrients from entering the lake. Nutrients entering the lake can contribute to eutrophication, resulting in increased aquatic vegetation, low oxygen levels, turbid water and algal blooms. Excess nutrient loading is one of the largest threats to water quality in lakes and rivers; it is everyone's responsibility to do something to help protect the lake.

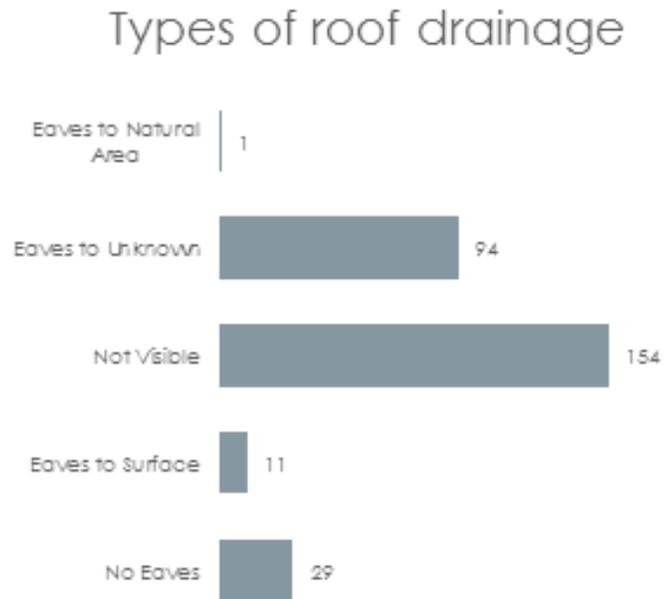
Figure 5 Roof Drainage types around lake

Naturalizing shorelines on properties with near-shore building setbacks would help reduce runoff from entering into Otter Lake, which could help reduce potential problems such as algae blooms and loss of oxygen in the water. Property owners can also manage this problem by ensuring they have eave troughs with downspouts directed at natural or stone catch basins or rain barrels, as well as ensuring they have a properly functioning septic to process wastewater before it enters the lake. As septic systems do very little to process nutrients, it is also important to use phosphate free products. Figure 5 shows the types of roof drainage that were recorded from the shoreline assessments.

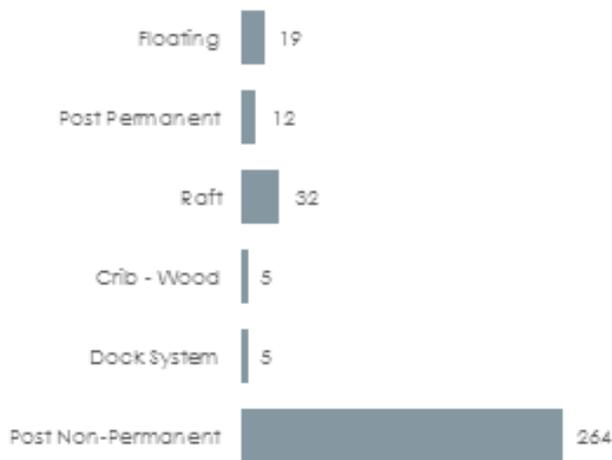
Figure 6 Docks On Lake

Shoreline development is defined as the presence of man-made structures in the water or along the shoreline within three metres of the shore. Development along a shoreline can be done sustainably and in an environmentally sensitive fashion, providing structures are well maintained and kept to a minimal footprint. Figure 6 and 7 illustrate the common structures present on Otter Lake.

On average property owners have developed 28% of their shoreline within a few metres of the water's edge. Different types of structures can have negative environmental impacts, due to their ability to remove habitat, store contaminants and nutrients, and eventually release them into the aquatic environment.

Small floating or non-permanent post docks are the most environmentally friendly choice, they allow natural water flow, have limited contact with the lake bottom, and reduce the overall potential for disturbance to aquatic life.

In the future, if shoreline property owners need to replace their old or failing permanent post, solid, or crib docks, they could consider choosing non-permanent post or floating docks. By selecting these types of docks, people can reduce the potential impacts to fish and other aquatic species, which can help protect the overall health of the lake environment.

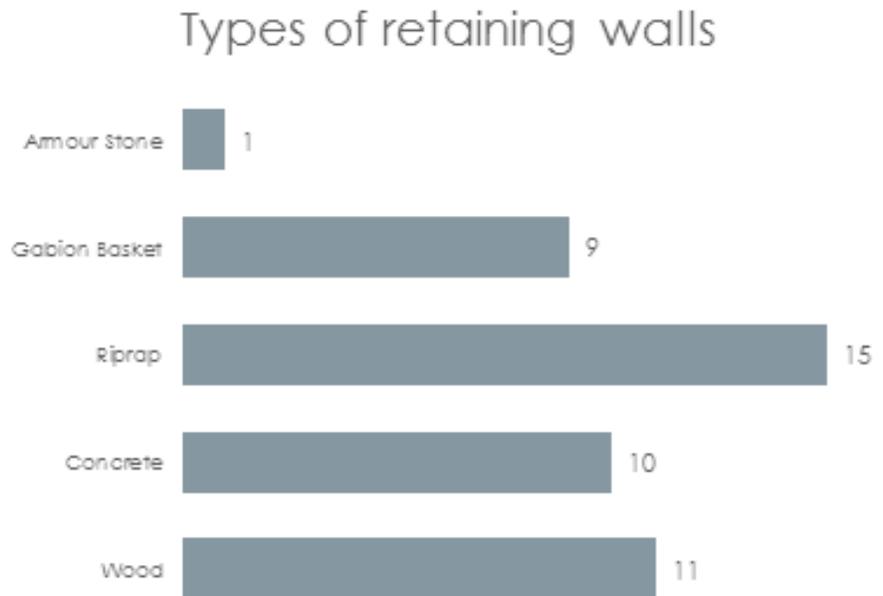
Figure 8 Retaining Walls on Lake

Retaining walls made out of rock, concrete, metal and other materials were once commonly used when it was thought that the only way to combat erosion was to take a hard, aggressive approach. Consequently, people began putting in concrete walls and gabion baskets. These structures only work in the short term to prevent erosion, but they ultimately do much more harm than good. On Otter Lake, the number of properties with retaining walls was observed and the results are summarized below in figure 8.

46 properties on Otter Lake, or 14% of the properties assessed have a retaining wall. Of the retaining walls that are present, the most common choice was Riprap. While retaining walls were an option to combat erosion for property owners in the past, we now know about their impact on the natural environment. Wave energy is reflected back from these hard, flat surfaces with the same force as which they strike the wall. This can cause excess turbulence in the water, which scours the sediments from the lake bottom. Solid walls also eliminate shoreline habitat and act as a barrier, preventing wildlife from reaching the water. Although some retaining walls such as riprap or loose rock have fewer impacts than other retaining walls, shoreline property owners could consider alternative erosion control methods such as planting native vegetated buffers. In the meantime, maintaining vegetation around the wall and allowing new vegetation to establish and grow will help reduce runoff and provide habitat for wildlife. For more information contact the provincial government regarding erosion control and necessary work permit requirements.

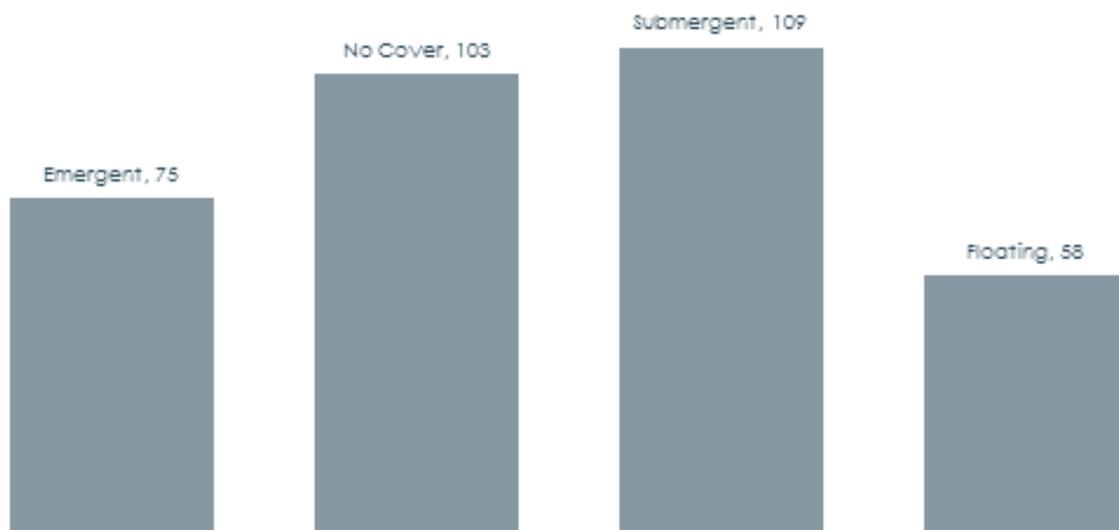
Figure 9 Aquatic Vegetation

On Otter Lake, shorelines were surveyed for their presence of aquatic plants. The presence of aquatic plants was further summarized into aquatic vegetation types; emergent, submergent, floating, and algal blooms. Figure 9 shows the number of properties on Otter Lake that had aquatic plants along their shoreline properties. The majority of aquatic vegetation that was present on Otter Lake was categorized as submergent vegetation. Emergent vegetation and floating vegetation were found less frequently on Otter Lake, but are still an important part of the aquatic ecosystem; giving habitat to birds, frogs, dragonflies and other wildlife.

When aquatic vegetation is removed, the integrity of the shoreline is lost. This negatively impacts the health of the waterbody by decreasing the quality of the water and reducing biodiversity. Eventually, a waterbody can become unusable, affecting the hundreds of species that rely on it. Fortunately, there are some easy steps that can be taken to help protect and restore your shoreline. By planting native species and allowing natural aquatic vegetation to grow, you can help provide habitat for wildlife to flourish.

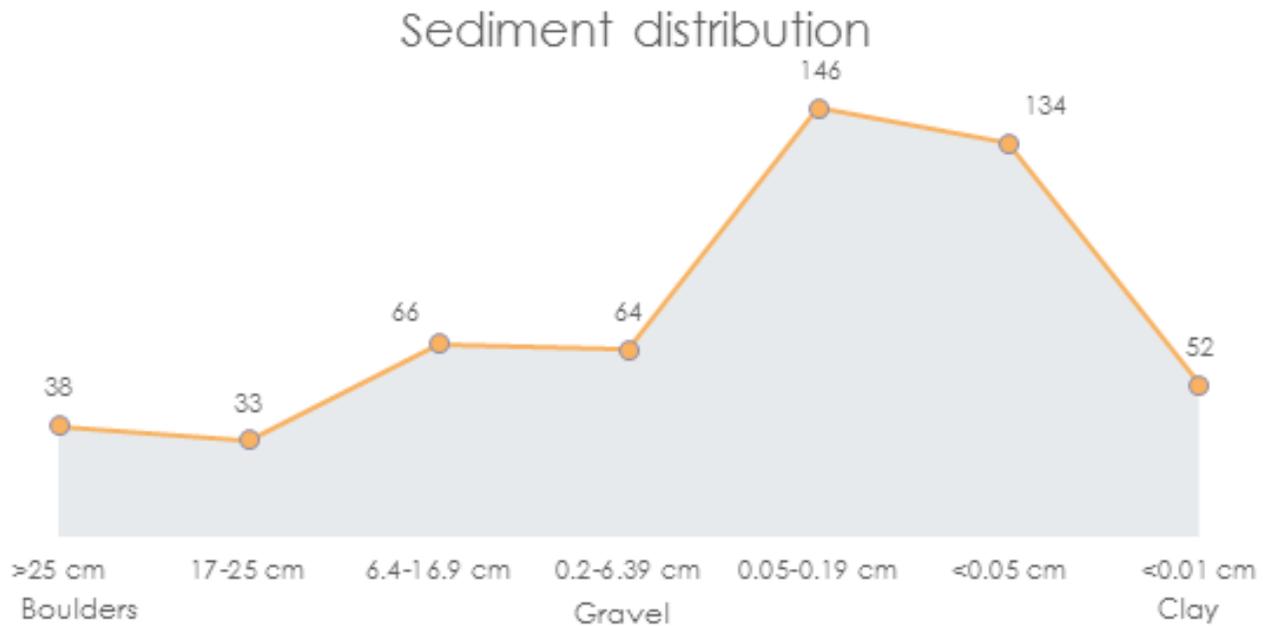
Figure 10 Sediment Distribution

On Otter Lake, the type of sediment present on the lake bottom was observed. The benthic zone which is located on the lake bottom is classified as the ecological region at the lowest level of a body of water. It starts at the shoreline and continues down until it reaches the floor, encompassing the sediment surface and subsurface layers. Although this zone may appear barren, it plays a vital role in the health of aquatic ecosystems. Tiny, microscopic organisms which cycle nutrients live in this zone and act as a source of food for bottom feeding animals.

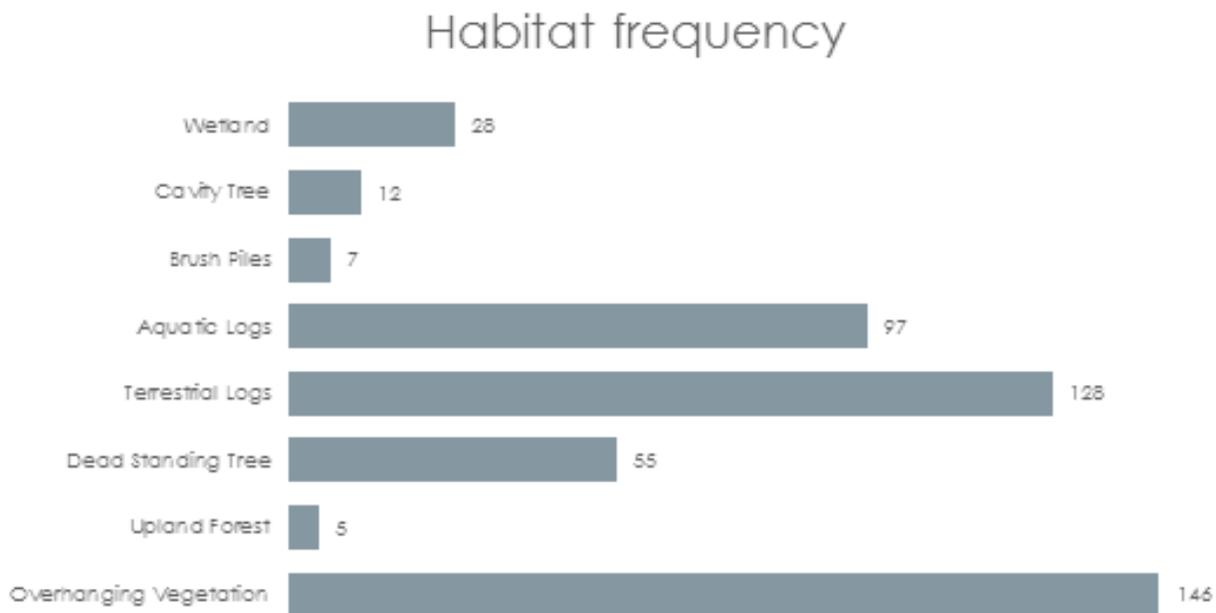
Figure 11 Habitat Present

The most common type of nearshore habitat on Otter Lake was identified as overhanging vegetation, followed by terrestrial logs. Wildlife provides us with many enjoyable and beneficial activities from bird watching and wildlife photography to pest control, seed dispersal, nutrient cycling and pollination, just to name a few. It is important for there to be a rich and diverse range of habitats along the lakeshore in order to ensure a healthy lake environment. Figure 11 summarizes the nearshore habitat.

It is important to leave large trees that are dead and dying in place, if it is safe to do so. They provide important habitat for a number of different wildlife species. In Ontario, more than 50 species of birds and mammals depend on cavity trees for nesting, rearing young, roosting, feeding, storing food, escaping predators and

hibernating. Fallen logs on land provide habitat for small mammals such as moles, woodpeckers, toads and insects. As the log decomposes, reptiles and amphibians lay their eggs in the moist wood. A decaying log is also great habitat for beetles and ants that burrow under the bark and lay eggs. In the water, logs provide important fish habitat by providing refuge for small fish and spaces for ambush predators such as pike to conceal themselves. By leaving dead and decaying brush and logs in place, you are helping contribute to a healthy and vibrant species community.

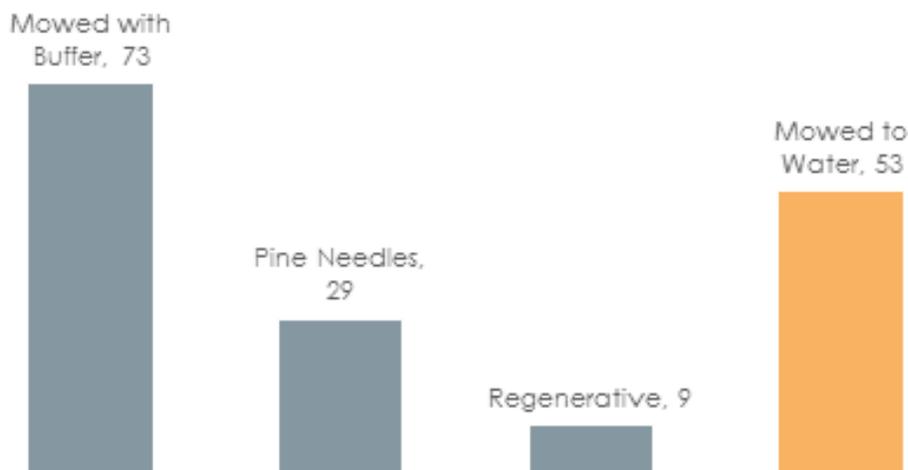
Figure 12 Lawn types

On Otter Lake, the number of properties with lawns, either mowed or regenerative, was observed. 16% of properties had lawns that were mowed to the water’s edge. When lawn is maintained to the water’s edge, natural ground cover and native vegetation are no longer present to slow runoff and allow nutrient filtration. Nutrients, contaminants, pollutants and other harmful substances can be easily carried into the lake by runoff and can harm water quality and local ecological integrity. Lawn grasses also have short root systems and do not bind the soil well, which can lead to problems with erosion and increased sediment deposition.

In areas close to shore, a lawn is generally not a good choice of ground cover. Half of precipitation runs off a mowed lawn directly into the lake, instead of returning to a natural groundwater source. If shoreline property owners wish to mitigate this, they could consider allowing vegetation to regenerate on its own or by actively planting native trees, shrubs, grasses, or alternative ground cover. The roots of the vegetation will grip the soil which can help prevent erosion. Allowing mowed lawns to regenerate to a more natural state promotes water conservation and protects surface and groundwater resources. Properties with regenerative lawns are encouraged to allow this natural process to continue and to enhance regeneration by planting native trees and shrubs.
