Otter Creek Catchment

Middle Rideau
Subwatershed
Report 2015

Middle Rideau Subwatershed Report 2015 OTTER LAKE AND CREEK CATCHMENT

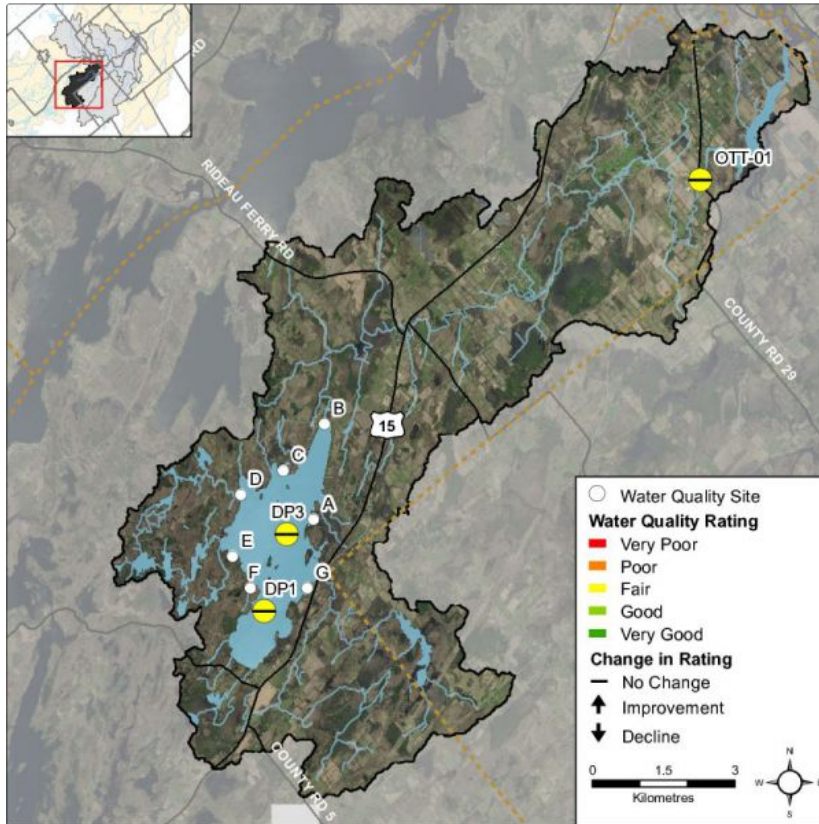
Figure 1 Water quality monitoring sites on Otter Lake and Creek

Surface water quality conditions in the Otter Lake and Creek catchment are monitored by the Rideau Valley Conservation Authority's (RVCA) Watershed Watch Program and Baseline Water Quality Monitoring Program. Watershed Watch monitors watershed lakes to assess nutrient concentrations, water clarity, dissolved oxygen availability and pH. The baseline water quality program focuses on streams; data is collected for 22 parameters including nutrients (total phosphorus, total Kjeldahl nitrogen and ammonia), *E. coli*, metals (like aluminum and copper) and additional chemical/physical parameters (such as alkalinity, chlorides, pH and total suspended solids). The locations of monitoring sites are shown in Figure 1 and Table 1.

This report also considers data from seven additional shoreline sites that are monitored around the lake. These sites have not been included in the calculation of the CCME WQI rating, as they are not monitored with the same frequency as deep point sites. However, they do provide important information on water quality conditions in the near shore areas. For locations of shoreline sites please see Figure 1.

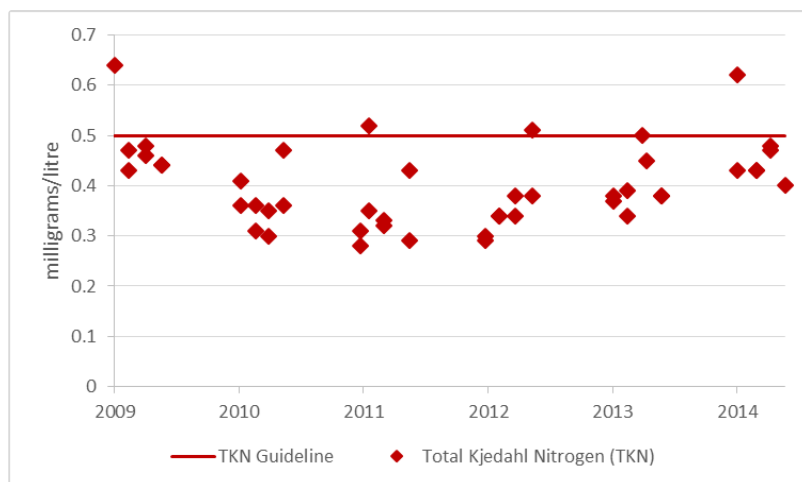
Figure 5 Total Kjeldahl nitrogen sampling results at deep point sites on Otter Lake, 2009-2014

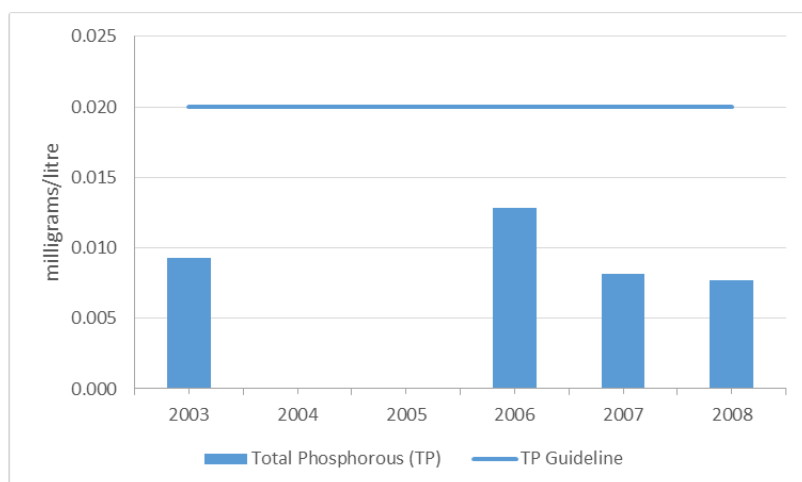
Figure 6 Average total phosphorous results at deep point sites on Otter Lake, 2003-2008

Average year to year concentrations have varied for both TP and TKN (Figures 6-9) from 2003-2008 and 2009-2014. An increase in average concentrations from 2008 to 2013 is visible, however all average TP and TKN results are below the guidelines in both monitoring periods (2003-2008 and 2009-2014). Overall, the data presented indicates that nutrient concentrations may be considered moderate in the mid-lake, deep water sites on Otter Lake.

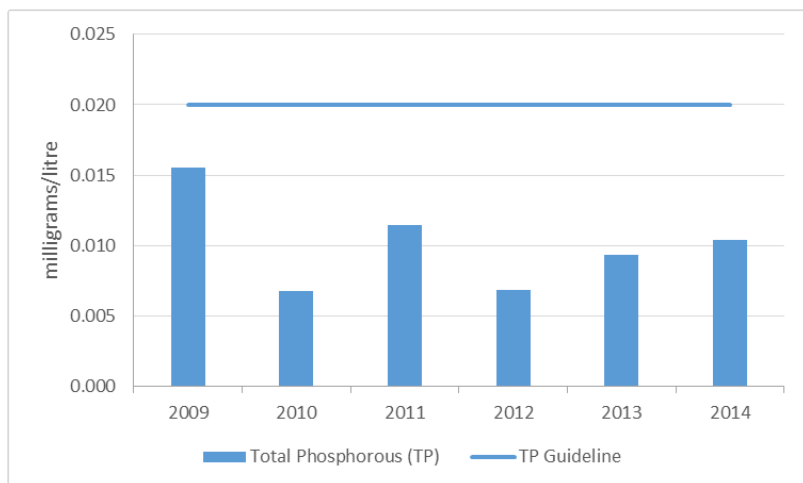
Figure 7 Average total phosphorous results at deep point sites on Otter Lake, 2009-2014

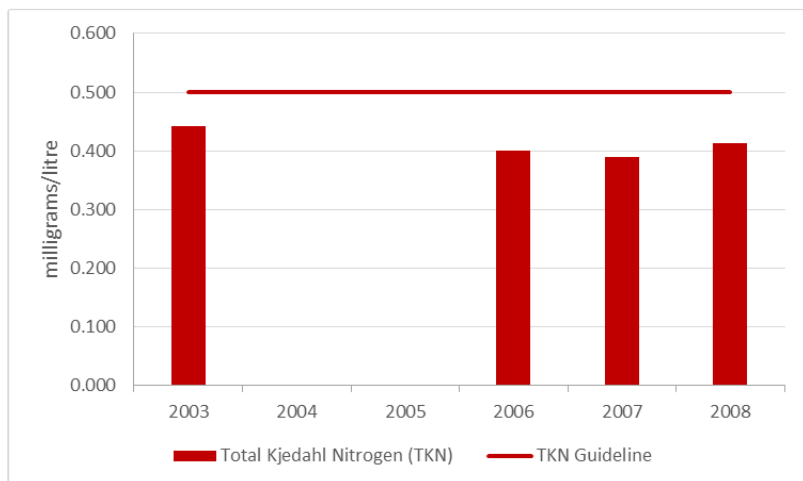
Figure 8 Average total Kjeldahl nitrogen results at deep point sites on Otter Lake, 2003-2008

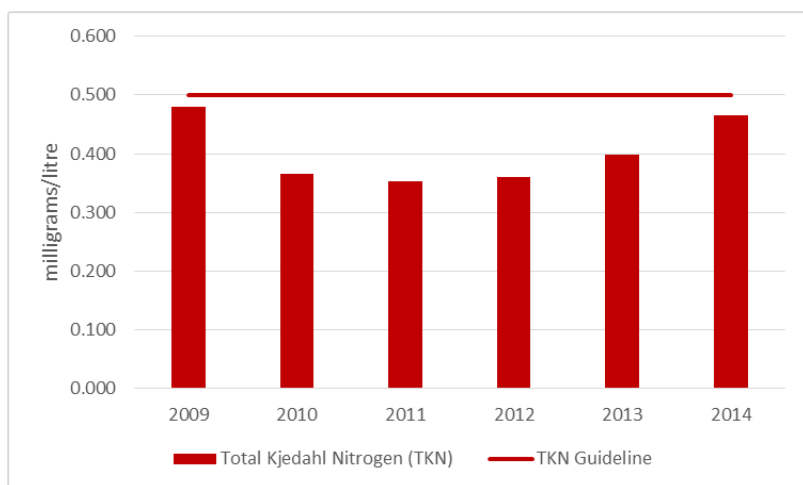
Figure 9 Average total kjeldahl nitrogen results at deep point sites on Otter Lake, 2009-2014

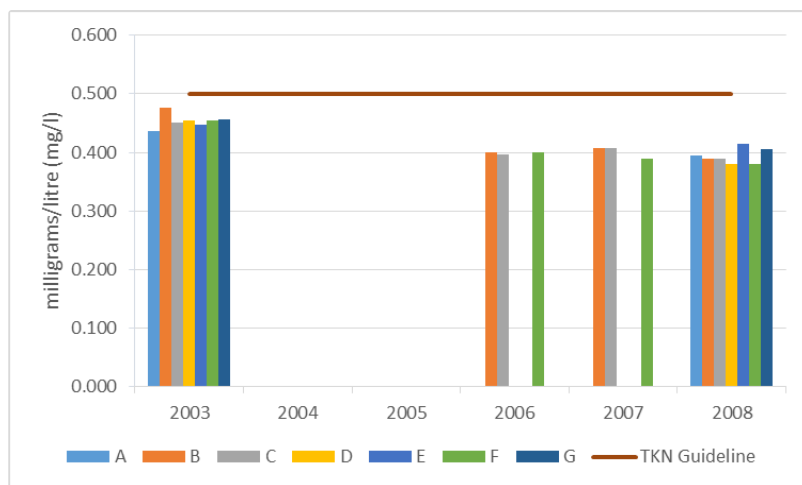
Figure 12 Average total Kjeldahl nitrogen concentrations at shoreline monitoring sites in Otter Lake, 2003-2008

TKN concentrations were also below the guideline at monitored sites; with the exception in 2013 at sites C and F which showed TKN concentrations above the guideline. Nutrient enrichment does not appear to be a problem in the monitored shoreline sites on Otter Lake (Figures 12 and 13).

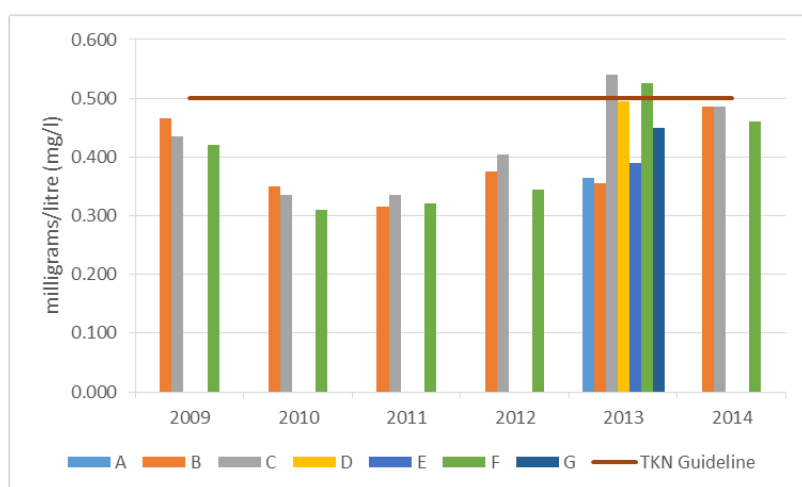
Figure 13 Average total Kjeldahl nitrogen concentrations at shoreline monitoring sites in Otter Lake, 2009-2014

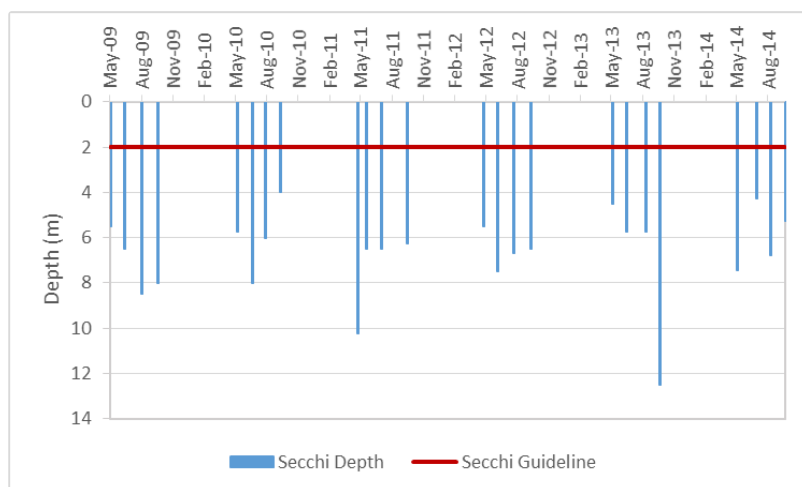
Figure 15 Recorded Secchi depths at the deep point sites on Otter Lake, 2009-2014

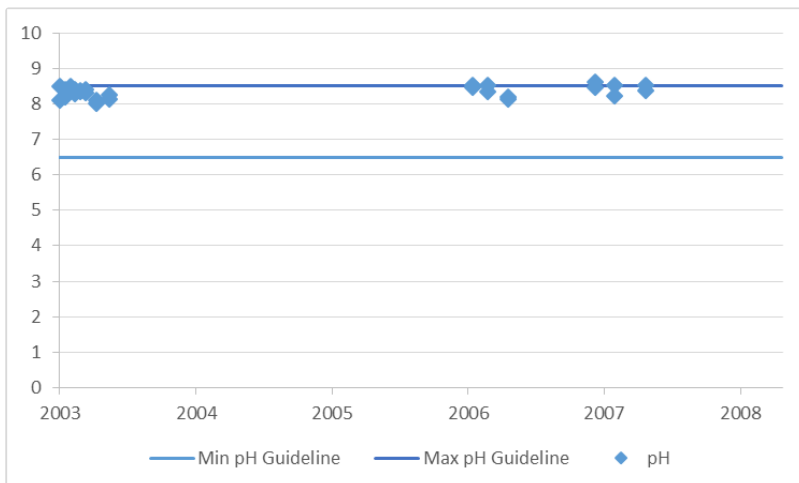
Figure 20 pH concentrations at the deep point sites on Otter Lake, 2003-2008

pH is a basic water quality parameter used to assess the acidity of water, an important factor for aquatic life. Figures 20 and 21 show pH concentrations in Otter Lake while Figures 22 and 23 summarize average concentrations by year.

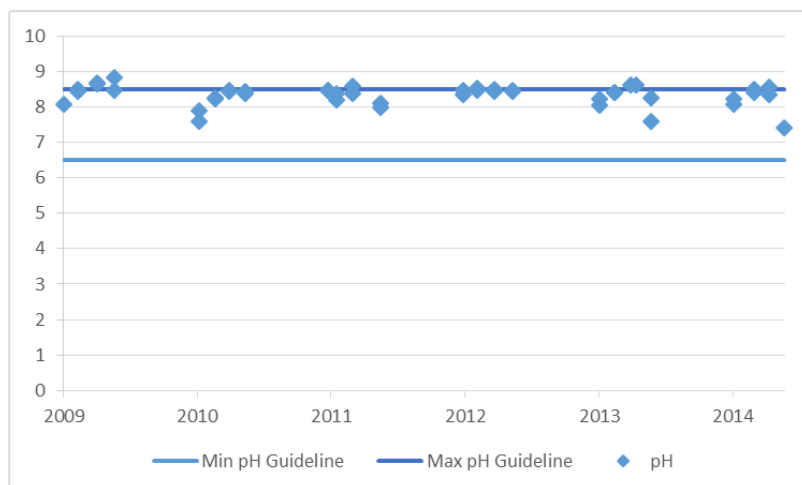
Figure 21 pH concentrations at the deep point sites on Otter Lake, 2009-2014

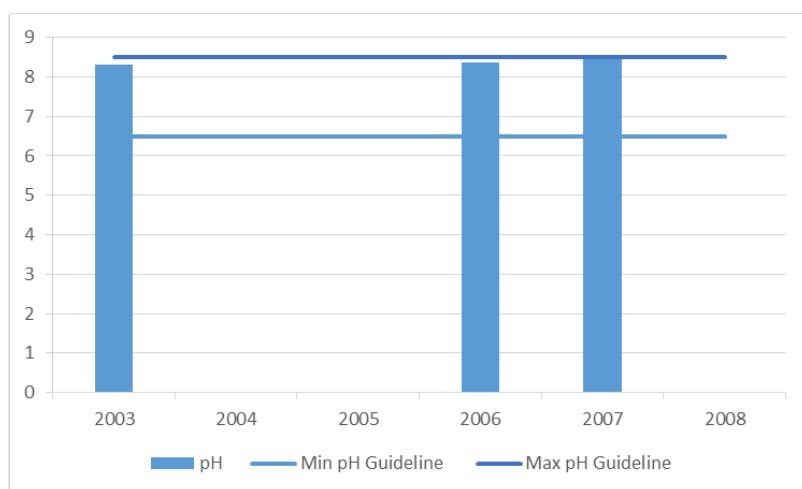
Figure 22 Average pH concentrations at the deep point sites on Otter Lake, 2003-2008

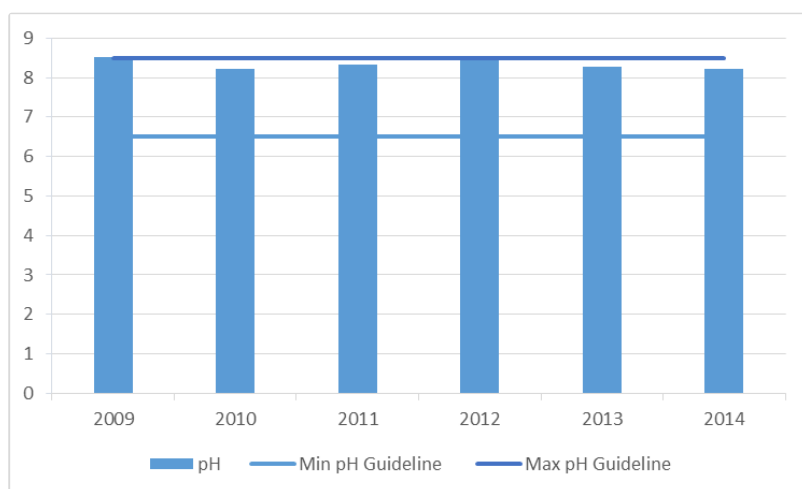
Figure 23 Average pH concentrations at the deep point sites on Otter Lake, 2009-2014

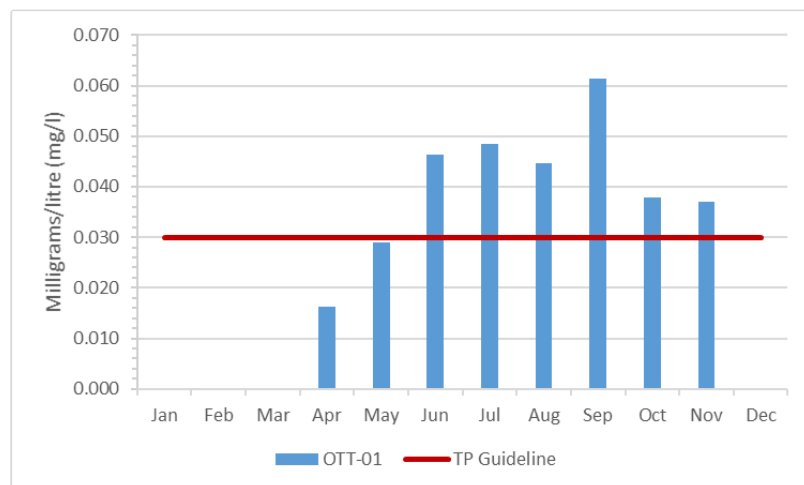
Figure 26 Total phosphorous concentrations in Otter Creek, 2003-2008

Elevated TP results were a regular occurrence in the 2003-2008 monitoring period at site OTT-01. The 2009-2014 monitoring period saw an improvement with less exceedances. Site OTT-01 had 29 percent of samples that were below the guideline in the 2003-2008 period (Figure 26); this increased to 59 percent of samples in the 2009-2014 period (Figure 27). The average TP concentration also decreased from 0.041 mg/l to 0.030 mg/l (Table 7).

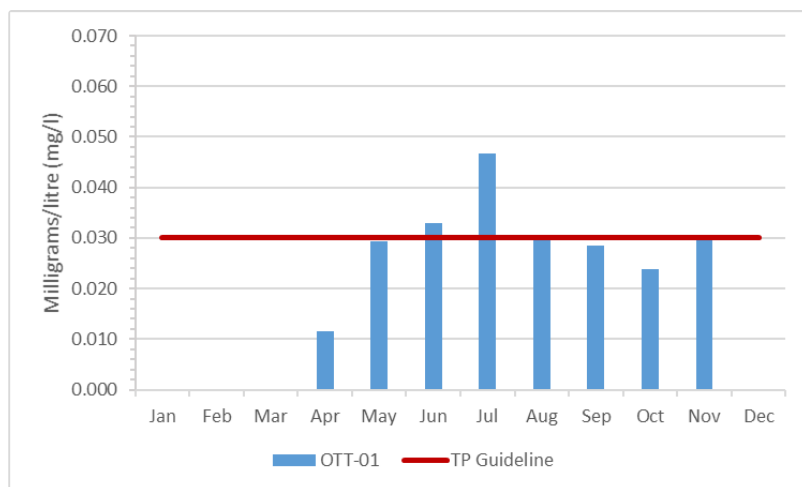
Figure 27 Total phosphorous concentrations in Otter Creek, 2009-2014

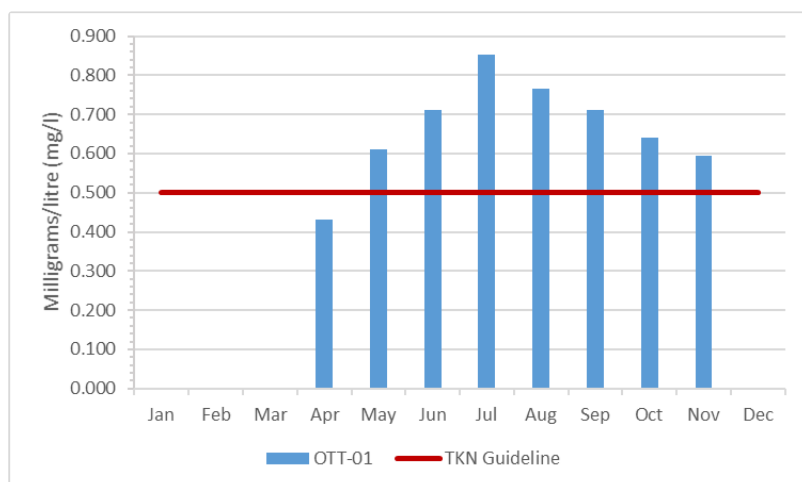
Figure 29 Total Kjeldahl nitrogen concentrations in Otter Creek, 2009-2014

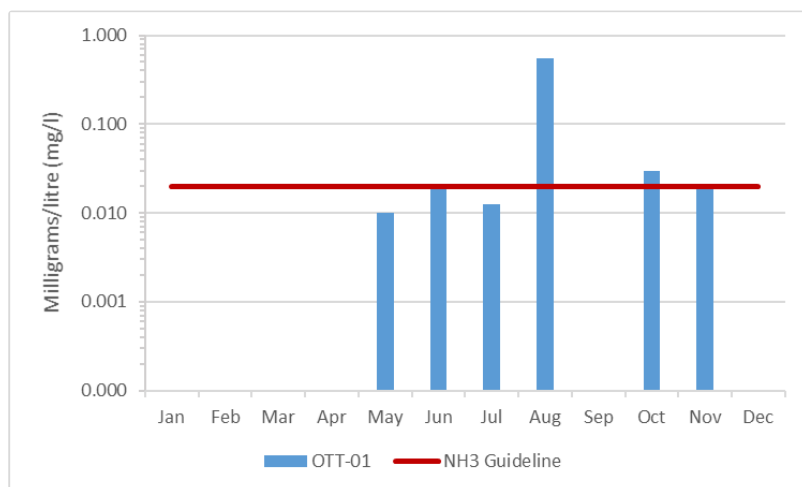
Figure 30 Ammonia concentrations in Otter Creek, 2003-2008

The trend of elevated nutrients is also observed in NH₃ data, as results at this site were generally above the guideline of 0.020 mg/l (Figures 30 and 31); the proportion of samples below the guideline remained the same with 58 percent. However, as observed with TP and TKN, this was accompanied by a decrease in the average concentration from 0.058 mg/l (2003-2008) to 0.016 mg/l (2009-2014).

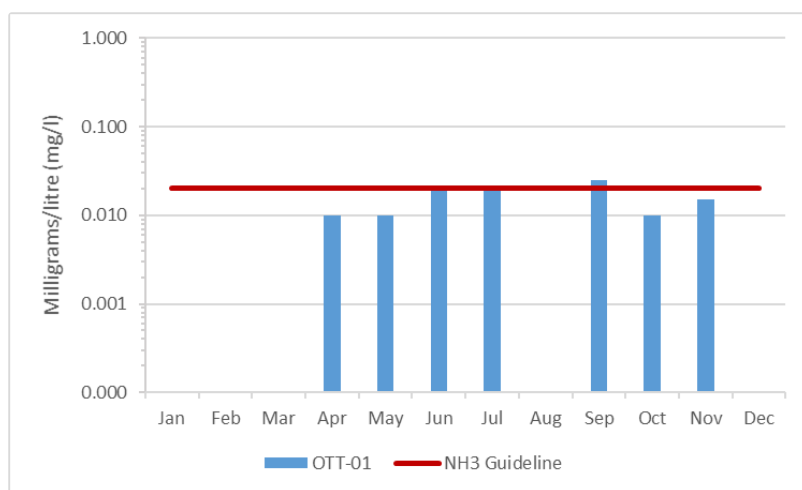
Figure 31 Ammonia concentrations in Otter Creek, 2009-2014

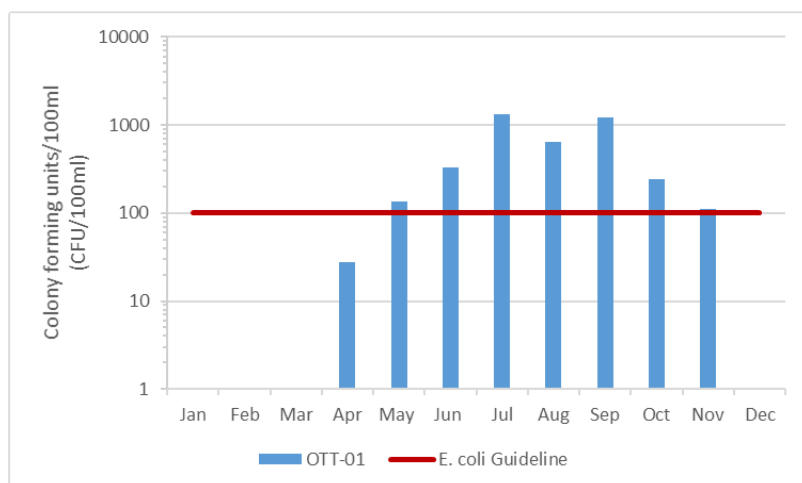
Figure 32 Geometric mean of E. coli results on Otter Creek, 2003-2008

E. coli results at site OTT-01 indicate bacterial counts are frequently above the E. coli guideline. The proportion of samples below the guideline improved from 21 percent (Figure 32) to 46 percent (Figure 33). Reduced counts are also observed at the geometric mean which declined from 313 CFU/100ml to 115 CFU/100ml (Table 10).

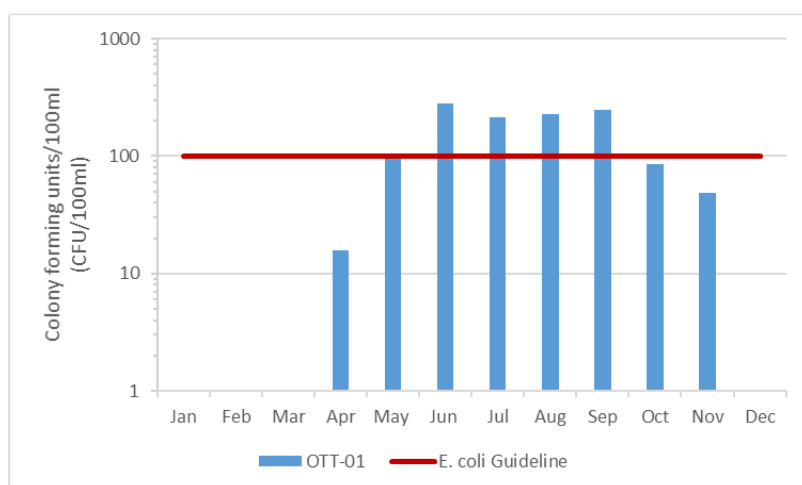
Figure 33 Geometric mean of E. coli results on Otter Creek, 2009-2014

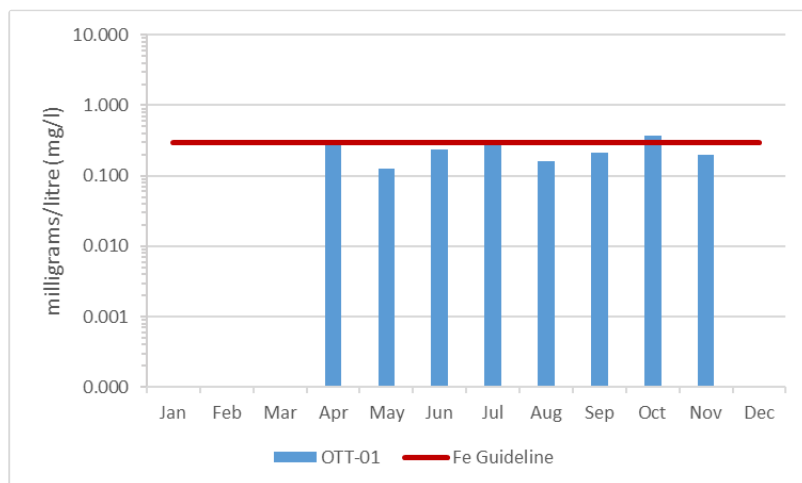
Figure 36 Average iron concentrations in Otter Creek, 2003-2008

Iron concentrations also exceeded the guideline. The proportion of samples below the guideline increased from 74 percent to 92 percent (Figures 36 and 37). Although there were observed exceedances, the average concentration did not exceed the guideline in both monitoring periods; 0.241 mg/l in 2003-2008 and .068 mg/l in 2009-2014.

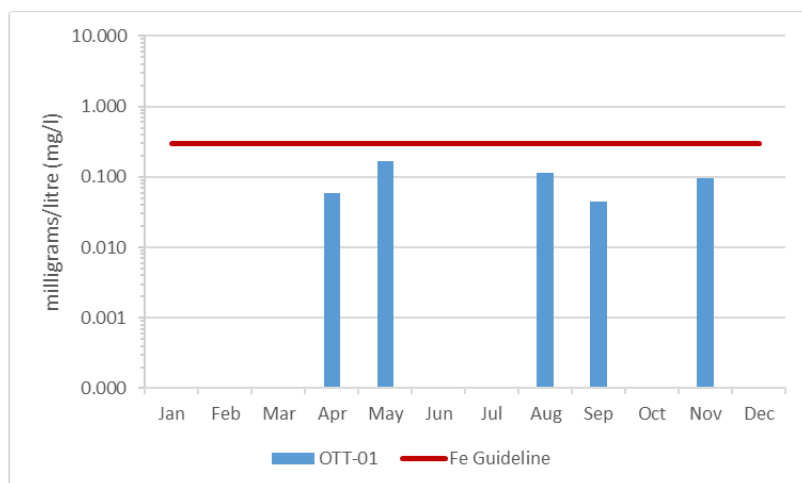
Figure 37 Average iron concentrations in Otter Creek, 2009-2014

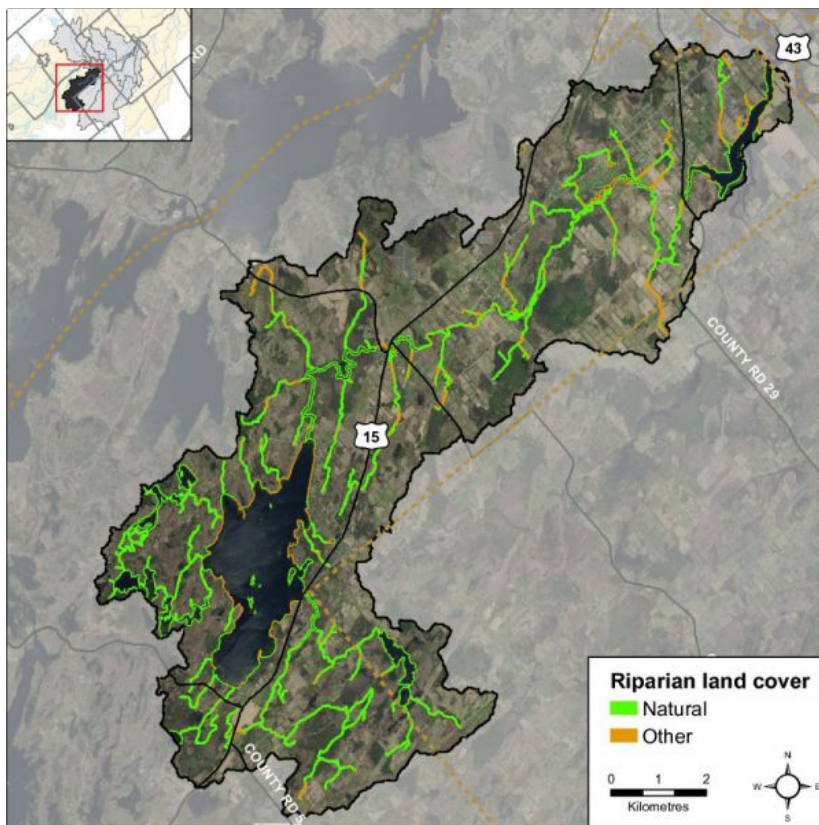
Figure 38 Natural and other riparian land cover in the Otter Lake and Creek catchment

Figure 38 shows the extent of the naturally vegetated riparian zone along a 30 metre wide strip of the shoreline of Otter Lake, Otter Creek and its tributaries. This information is derived from a dataset developed by the RVCA's Land Cover Classification Program through heads-up digitization of 20cm DRAPE ortho-imagery at a 1:4000 scale, which details the catchment landscape using 10 land cover classes.

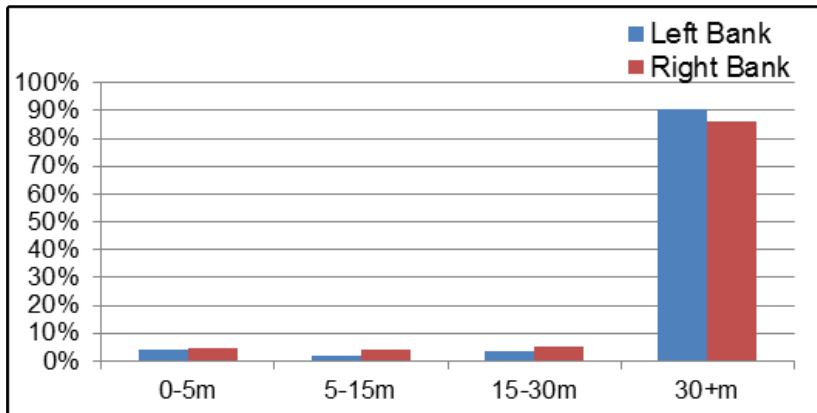
Figure 39 Riparian buffer evaluation along Otter Creek

Figure 39 demonstrates the buffer conditions of the left and right banks separately. Otter Creek had a buffer of greater than 30 meters along 86 percent of the right bank and 91 percent of the left bank.

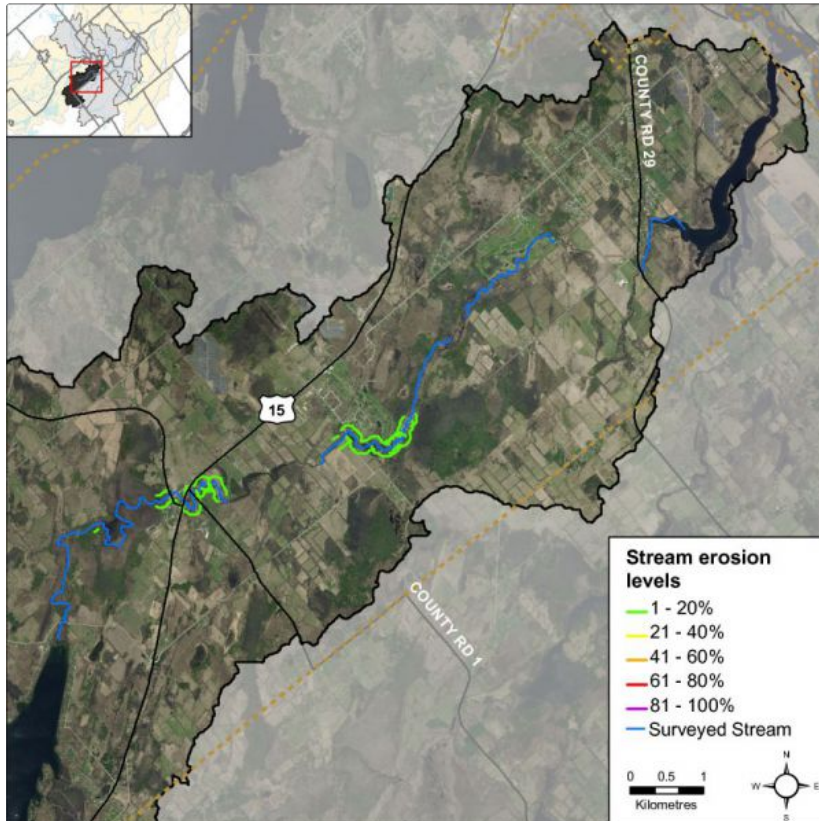
Figure 41 Erosion along Otter Creek

Erosion is a normal, important stream process and may not affect actual bank stability; however, excessive erosion and deposition of sediment within a stream can have a detrimental effect on important fish and wildlife habitat. Poor bank stability can greatly contribute to the amount of sediment carried in a waterbody as well as loss of bank vegetation due to bank failure, resulting in trees falling into the stream and the potential to impact instream migration. Figure 41 shows low levels of erosion along Otter Creek.

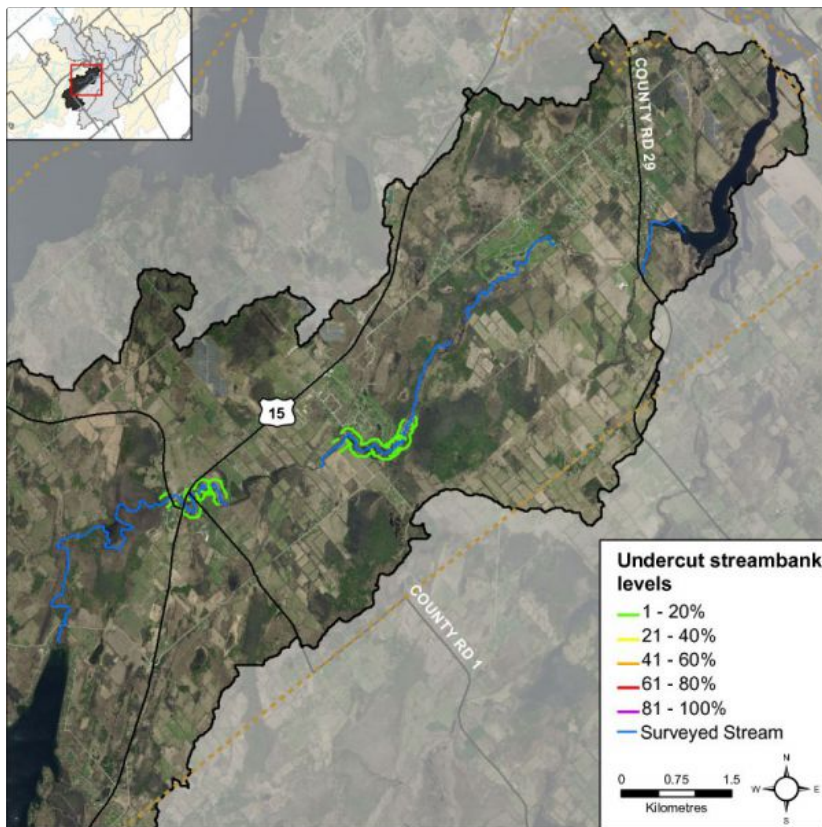
Figure 42 Undercut stream banks along Otter Creek

Undercut banks are a normal and natural part of stream function and can provide excellent refuge areas for fish. Figure 42 shows that Otter Creek had low levels of undercut banks.

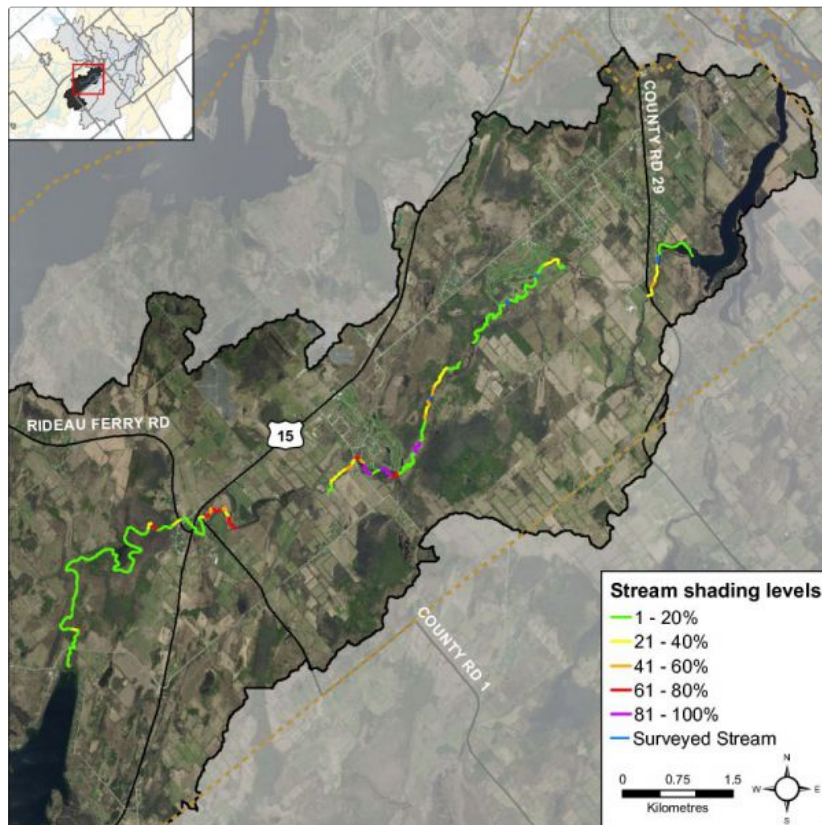
Figure 43 Stream shading along Otter Creek

Grasses, shrubs and trees all contribute towards shading a stream. Shade is important in moderating stream temperature, contributing to food supply and helping with nutrient reduction within a stream. Figure 43 shows highly variable stream shading conditions ranging from low levels to high levels along Otter Creek.

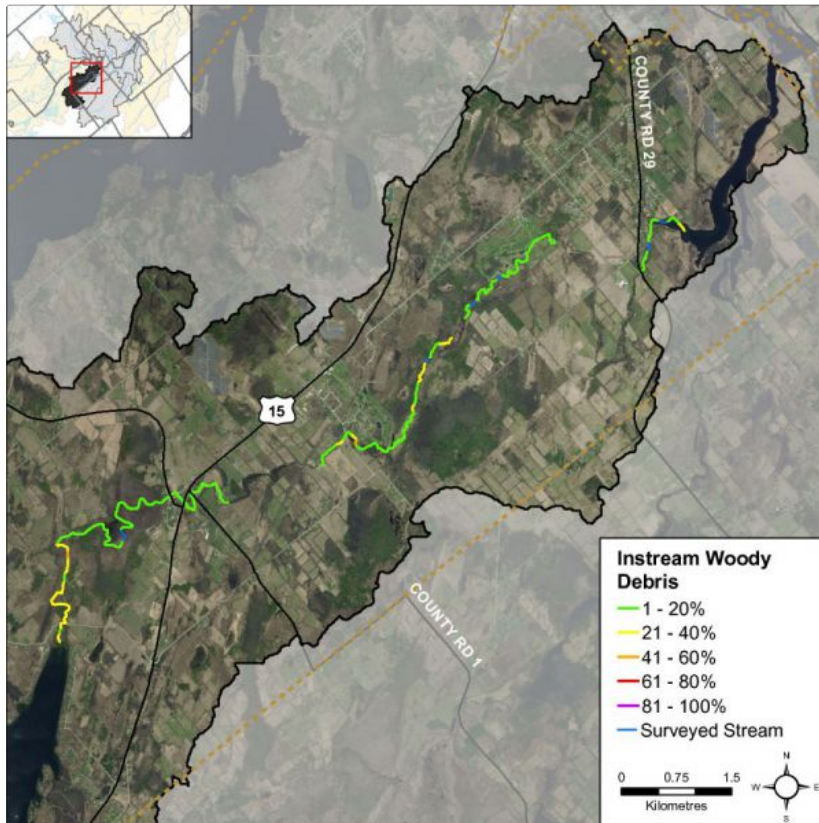
Figure 44 Instream woody debris along Otter Creek

Figure 44 shows that the majority of Otter Creek had low to moderate levels of instream woody debris in the form of branches and trees. Instream woody debris is important for fish and benthic invertebrate habitat, by providing refuge and feeding areas.

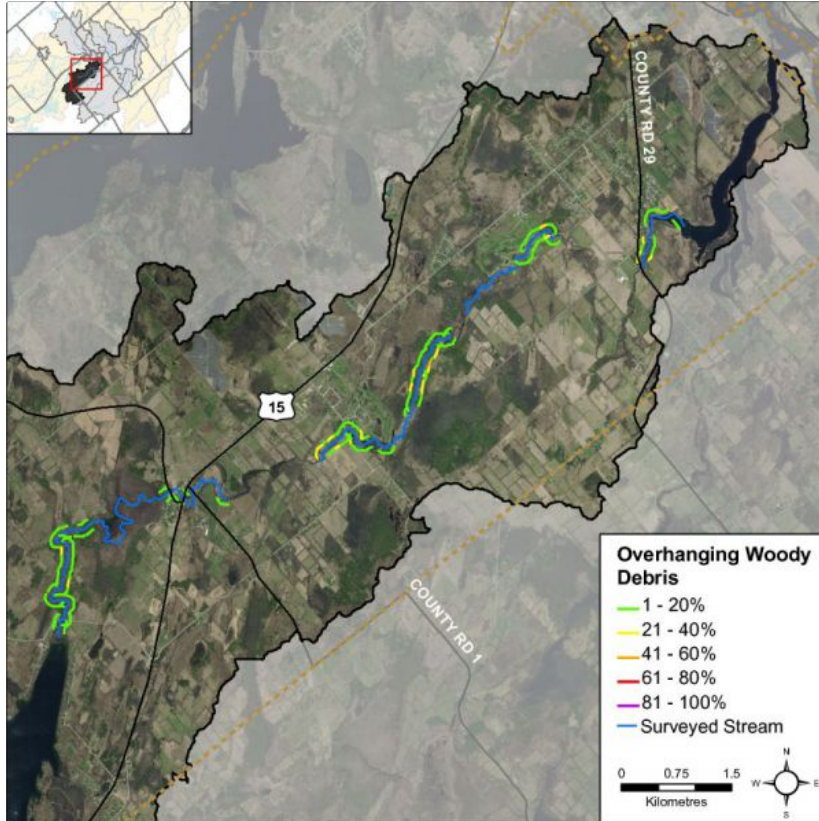
Figure 45 Overhanging trees and branches along Otter Creek

Figure 45 shows low levels of overhanging branches and trees along Otter Creek. Overhanging branches and trees provide a food source, nutrients and shade which helps to moderate instream water temperatures.

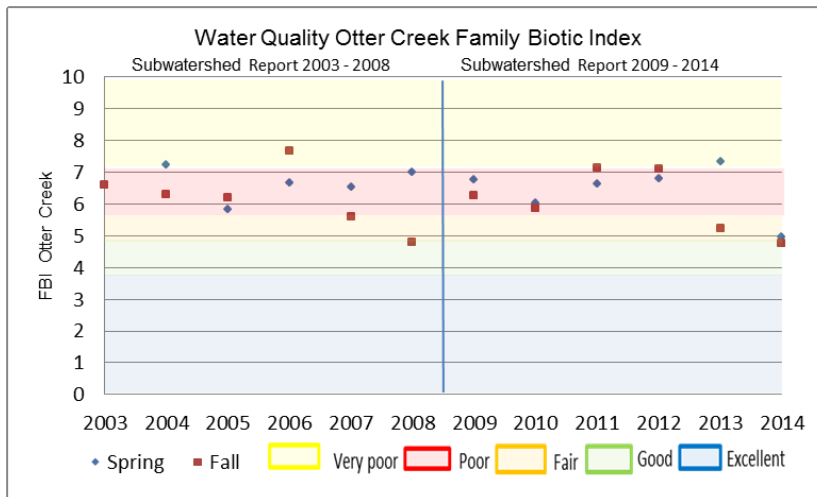
Figure 47 Hilsenhoff Family Biotic Index on Otter Creek

The Hilsenhoff Family Biotic Index (FBI) is an indicator of organic and nutrient pollution and provides an estimate of water quality conditions for each site using established pollution tolerance values for benthic invertebrates. FBI results for Otter Creek are separated by reporting period 2003 to 2008 and 2009 to 2014. "Very Poor" to "Fair" water quality conditions being observed at the Otter Creek sample location for the period from 2003 to 2014 (Fig.47) using a grading scheme developed by Conservation Authorities in Ontario for benthic invertebrates.

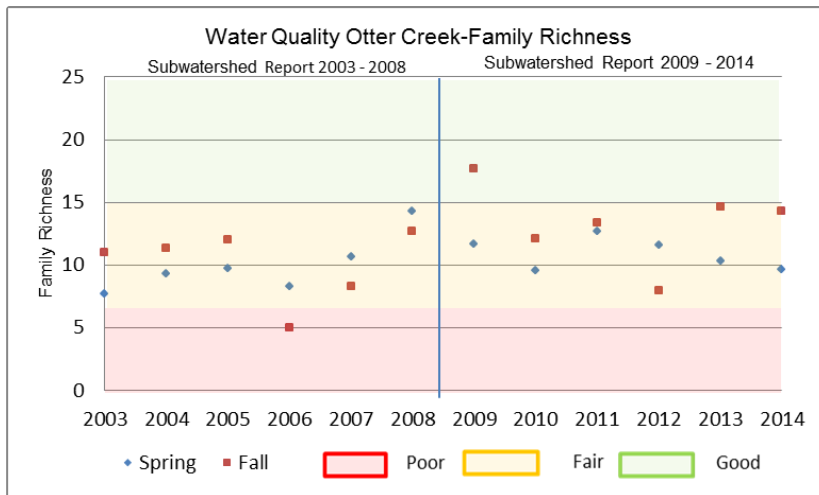
Figure 48 Family Richness in Otter Creek

Family Richness measures the health of the community through its diversity and increases with increasing habitat diversity suitability and healthy water quality conditions. Family Richness is equivalent to the total number of benthic invertebrate families found within a sample. Although the family richness appears to be fair for the Otter Creek sample location the samples are dominated by species that are moderately tolerant and tolerant to poor water quality conditions. Otter Creek is reported to have "Fair" family richness (Fig.48).

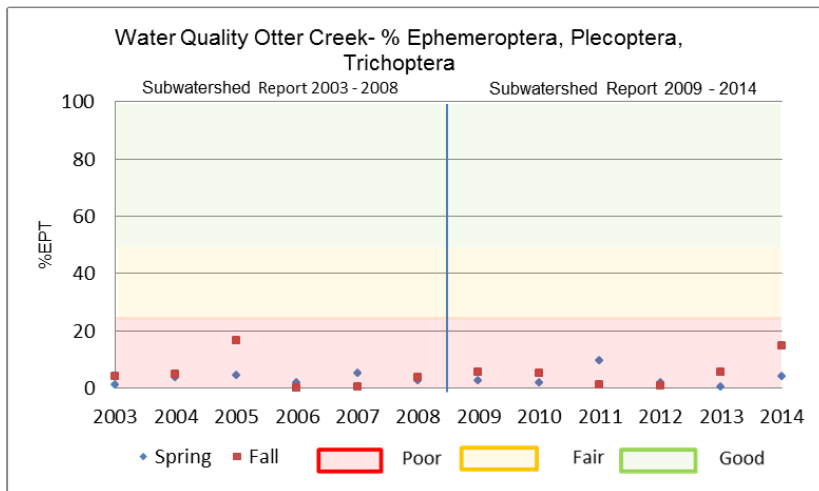
Figure 49 EPT in Otter Creek

Ephemeroptera (Mayflies), *Plecoptera* (Stoneflies), and *Trichoptera* (Caddisflies) are species considered to be very sensitive to poor water quality conditions. High abundance of these organisms is generally an indication of good water quality conditions at a sample location. The community structure is dominated by species that are not sensitive to poor water quality conditions. As a result, the EPT indicates that Otter Creek is reported to have “Poor” water quality (Fig. 49) from 2003 to 2014.

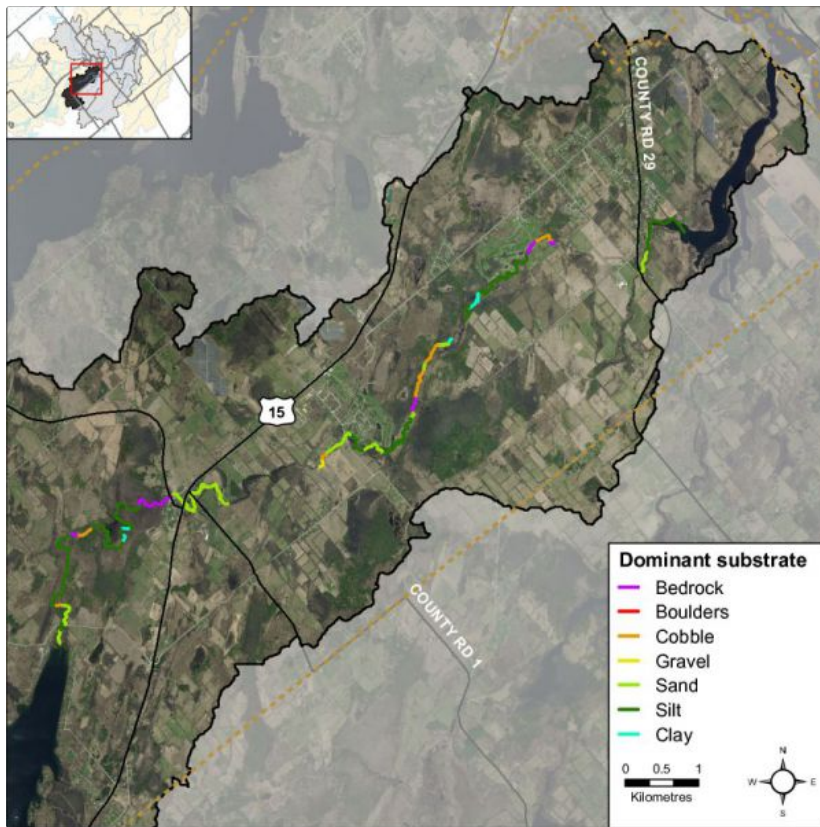
Figure 52 Dominant instream substrate along Otter Creek

Diverse substrate is important for fish and benthic invertebrate habitat because some species have specific substrate requirements and for example will only reproduce on certain types of substrate. Figure 51 shows that 36 percent of the substrate observed on Otter Creek was dominated by silt. Overall substrate conditions were highly variable along Otter Creek. Figure 52 shows the dominant substrate along Otter Creek.

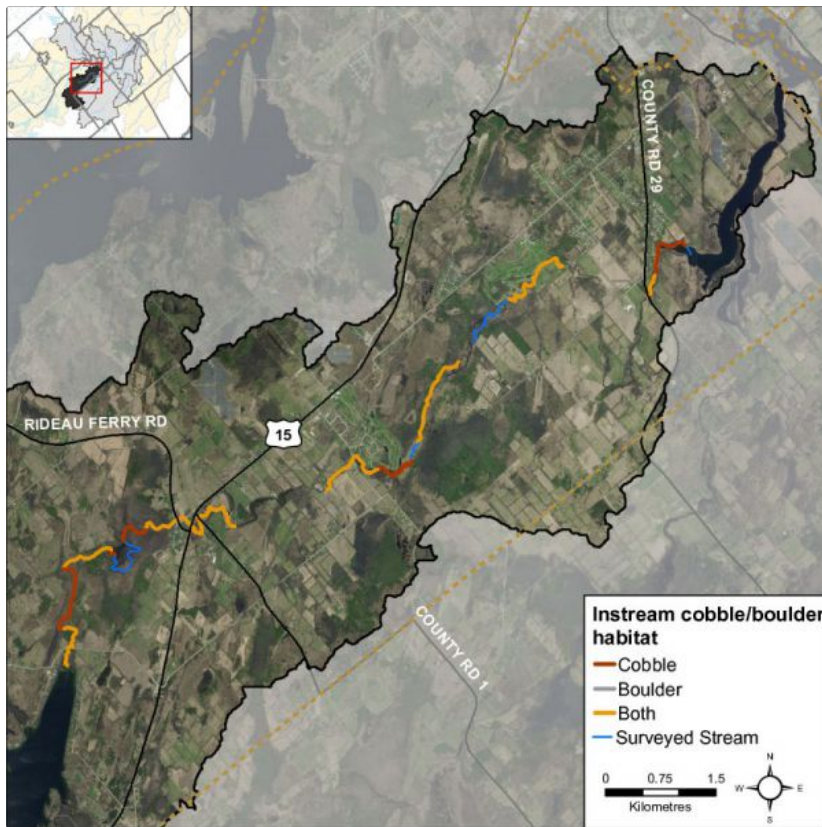
Figure 53 Instream cobble and boulder along Otter Creek

Boulders create instream cover and back eddies for large fish to hide and/or rest out of the current. Cobble provides important spawning habitat for certain fish species like walleye and various shiner species who are an important food source for larger fish. Cobble can also provide habitat conditions for benthic invertebrates that are a key food source for many fish and wildlife species. Figure 53 shows where cobble and boulder substrate are found in Otter Creek.

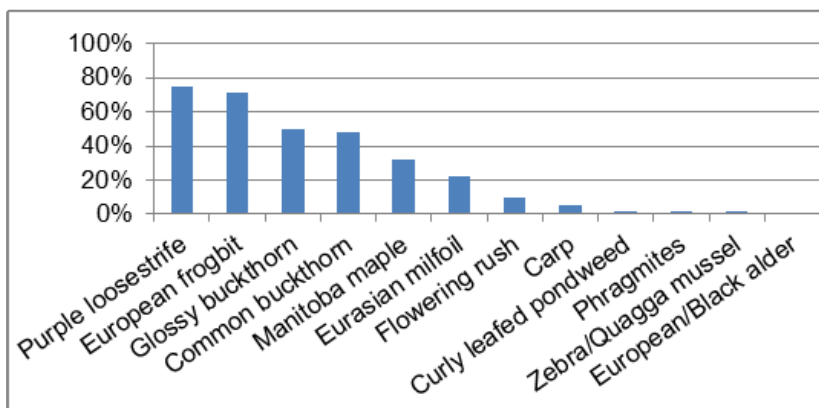
Figure 60 Invasive species frequency by type along Otter Creek

European/black alder and Manitoba maple. Figure 60 shows the frequency of the invasive species observed along Otter Creek.

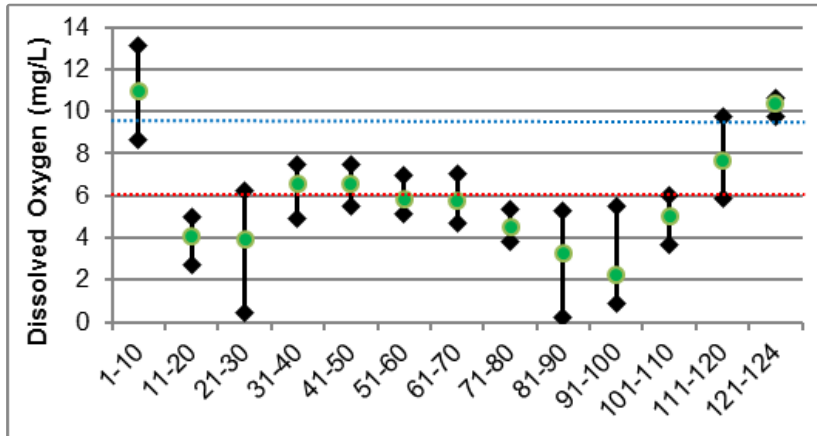
Figure 61 Dissolved oxygen ranges in Otter Creek

Dissolved oxygen is a measure of the amount of oxygen dissolved in water. The Canadian Environmental Quality Guidelines of the Canadian Council of Ministers of the Environment (CCME) suggest that for the protection of aquatic life the lowest acceptable dissolved oxygen concentration should be 6 mg/L for warmwater biota and 9.5 mg/L for coldwater biota (CCME, 1999). Figure 61 shows that the dissolved oxygen in the Otter Creek was well below the threshold for warmwater biota in several reaches of the system. The average dissolved oxygen levels observed

within the main stem of Otter Creek was 5.90mg/L which is below the 6mg/L minimum that is recommended for warmwater biota.

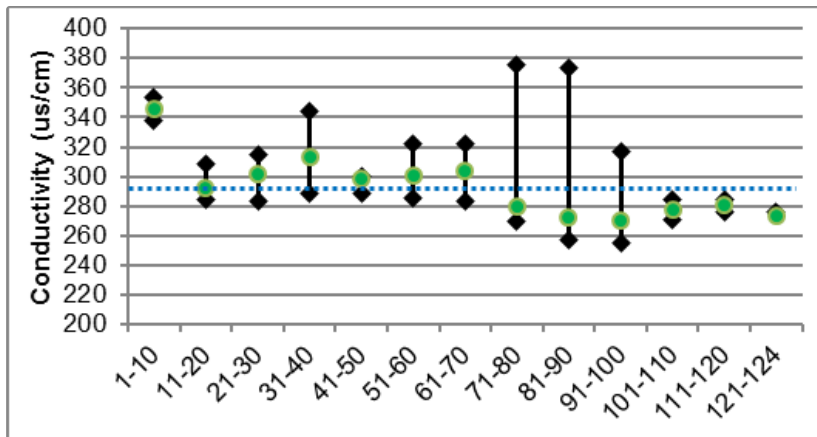
Figure 62 Conductivity ranges in Otter Creek

Conductivity in streams is primarily influenced by the geology of the surrounding environment, but can vary drastically as a function of surface water runoff. Currently there are no CCME guideline standards for stream conductivity, however readings which are outside the normal range observed within the system are often an indication of unmitigated discharge and/or stormwater input. The average conductivity observed within the main stem of Otter Creek was 294 $\mu\text{S}/\text{cm}$. Figure 62 shows that the conductivity readings for Otter Creek.

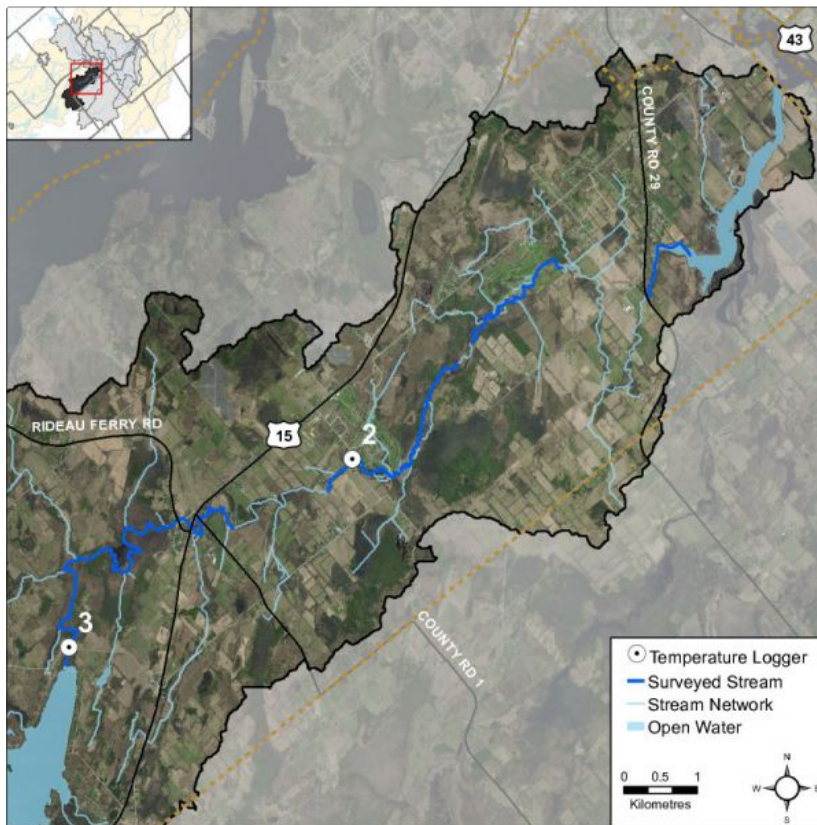
Figure 64 Temperature loggers in Otter Creek

Many factors can influence fluctuations in stream temperature, including springs, tributaries, precipitation runoff, discharge pipes and stream shading from riparian vegetation. Water temperature is used along with the maximum air temperature (using the Stoneman and Jones method) to classify a watercourse as either warm water, cool water or cold water. Figure 64 shows the location of temperatures loggers at two sampling locations along Otter Creek.

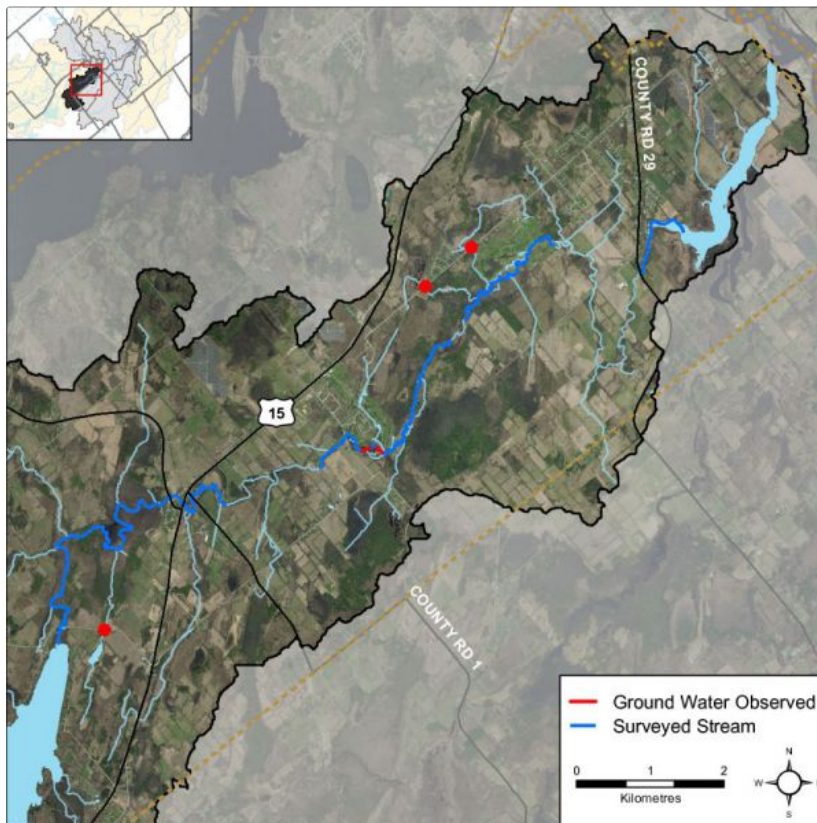
Figure 66 Groundwater indicator observations in the Otter Creek catchment

Groundwater discharge areas can influence stream temperature, contribute nutrients, and provide important stream habitat for fish and other biota. During stream surveys, indicators of groundwater discharge are noted when observed. Indicators include: springs/seeps, watercress, iron staining, significant temperature change and rainbow mineral film. Figure 66 shows areas where one or more of the above groundwater indicators were observed during stream surveys and headwater assessments.

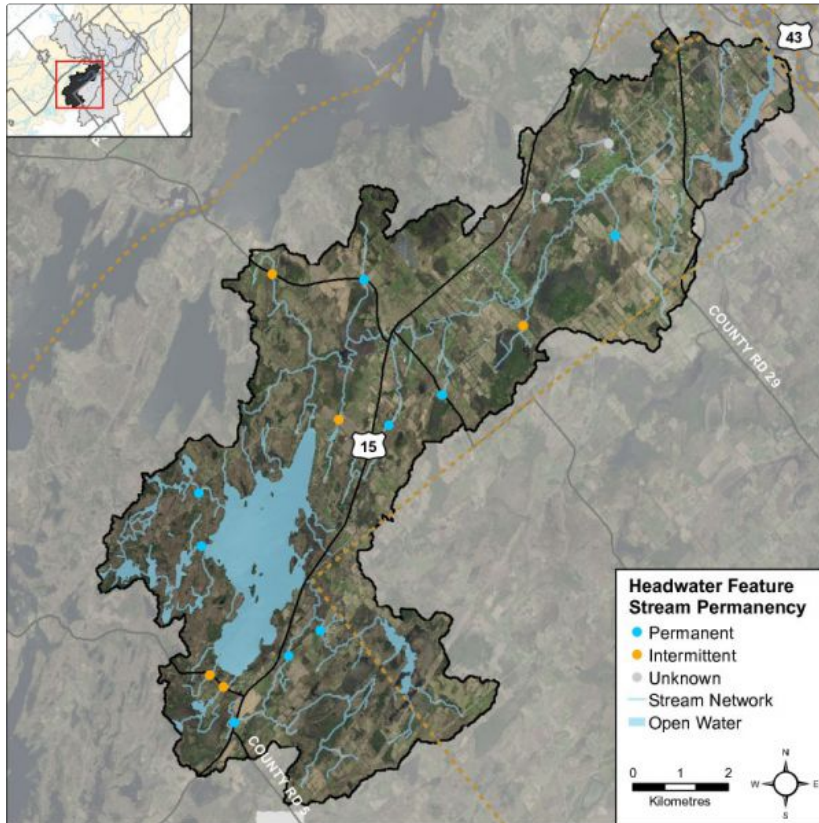
Figure 69 headwater flow type in Otter Creek

The observed flow condition within headwater drainage features can be highly variable depending on timing relative to the spring freshet, recent rainfall, soil moisture, etc. Flow conditions are assessed in the spring and in the summer to determine if features are perennial and flow year round, if they are intermittent and dry up during the summer months or if they are ephemeral systems that do not flow regularly and generally respond to specific rainstorm events or snowmelt. Flow conditions in headwater systems can change from year to year depending on location precipitation patterns. Figure 69 shows the observed flow conditions at the sampling locations in the Otter Creek catchment.
