Otter Creek Catchment

Middle Rideau
Subwatershed
Report 2015

Middle Rideau Subwatershed Report 2015 OTTER LAKE AND CREEK CATCHMENT

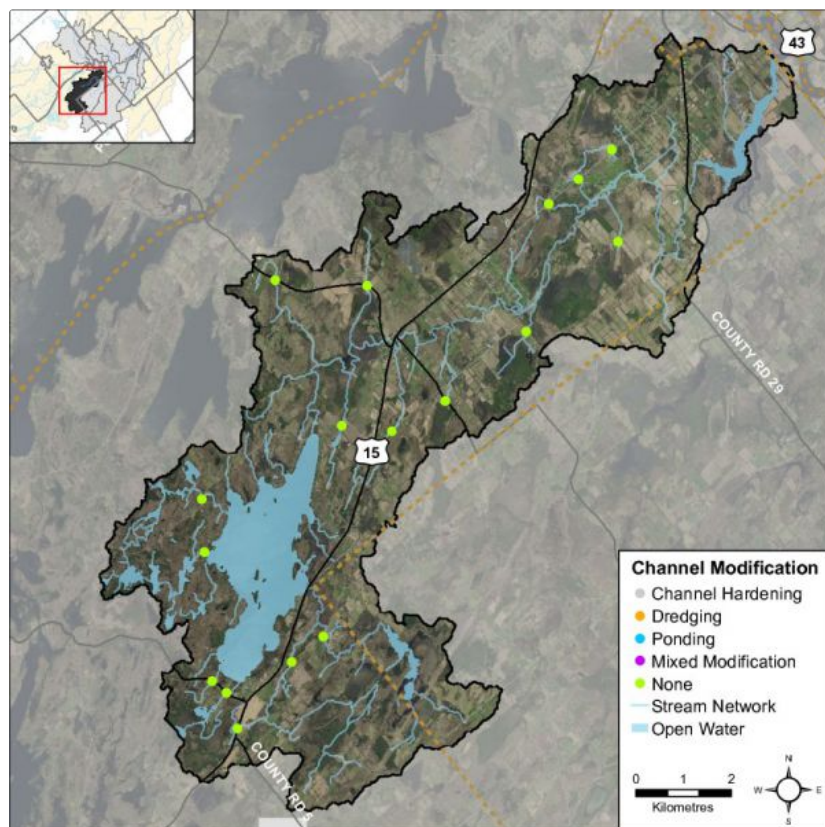
Figure 70 headwater feature channel modifications in Otter Creek

Channel modifications were assessed at each headwater drainage feature sampling location. Modifications include channelization, dredging, hardening and realignments. The sampling locations for the Otter Creek catchment area were classified as having no channel modifications. Figure 70 shows the channel modifications observed at the sampling locations for Otter Creek.

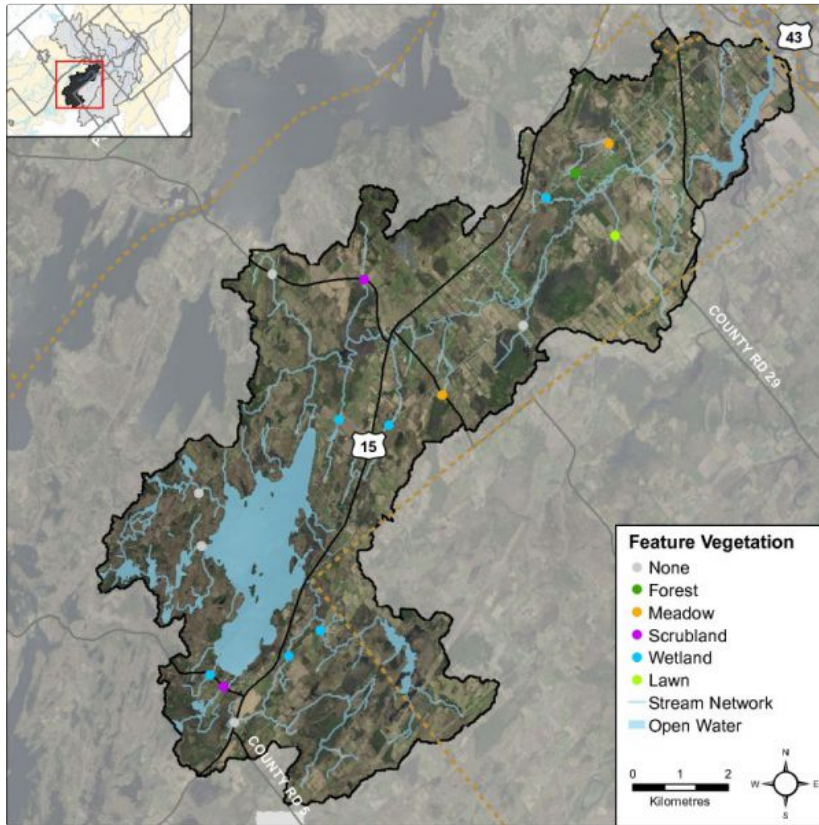
Figure 71 headwater feature vegetation types in Otter Creek

Headwater feature vegetation evaluates the type of vegetation that is found within the drainage feature. The type of vegetated within the channel influences the aquatic and terrestrial ecosystem values that the feature provides. For some types of headwater features the vegetation within the feature plays a very important role in flow and sediment movement and provides wildlife habitat. The following classifications are evaluated no vegetation, lawn, wetland, meadow, scrubland and forest. Figure 71 depicts the dominant vegetation observed at the sampled headwater sites in the Otter Creek catchment.

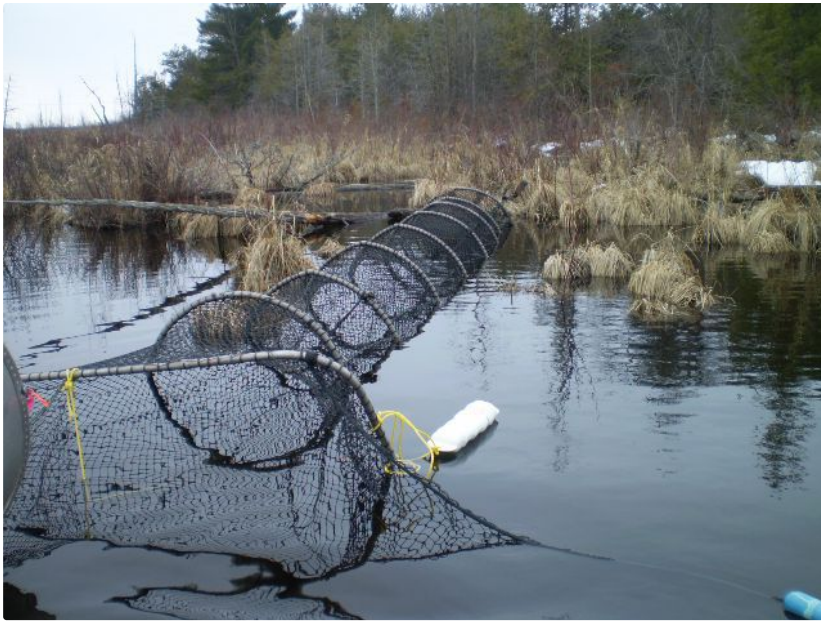
Fyke net set along Otter Creek

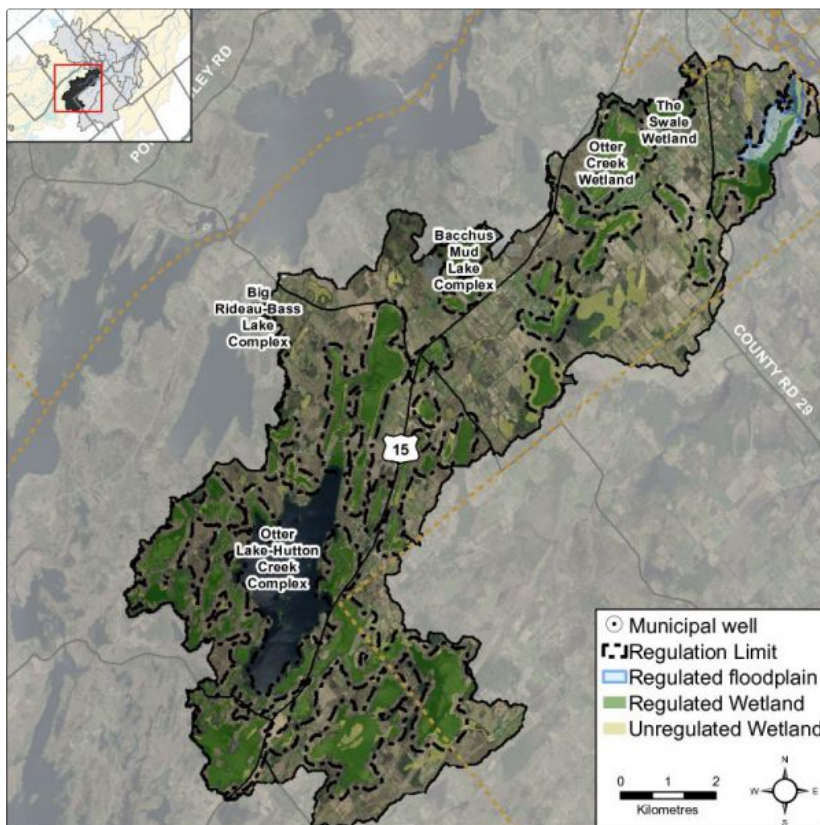
Figure 82 RVCA regulation limits
